AAIS Case Reference: 13/2010

# **AIR ACCIDENT INVESTIGATION REPORT**

**Uncontained Cargo Fire Leading to Loss of Control  
Inflight and Uncontrolled Descent Into Terrain**

Boeing 747-44AF  
N571UP  
Dubai  
United Arab Emirates  
03 September 2010

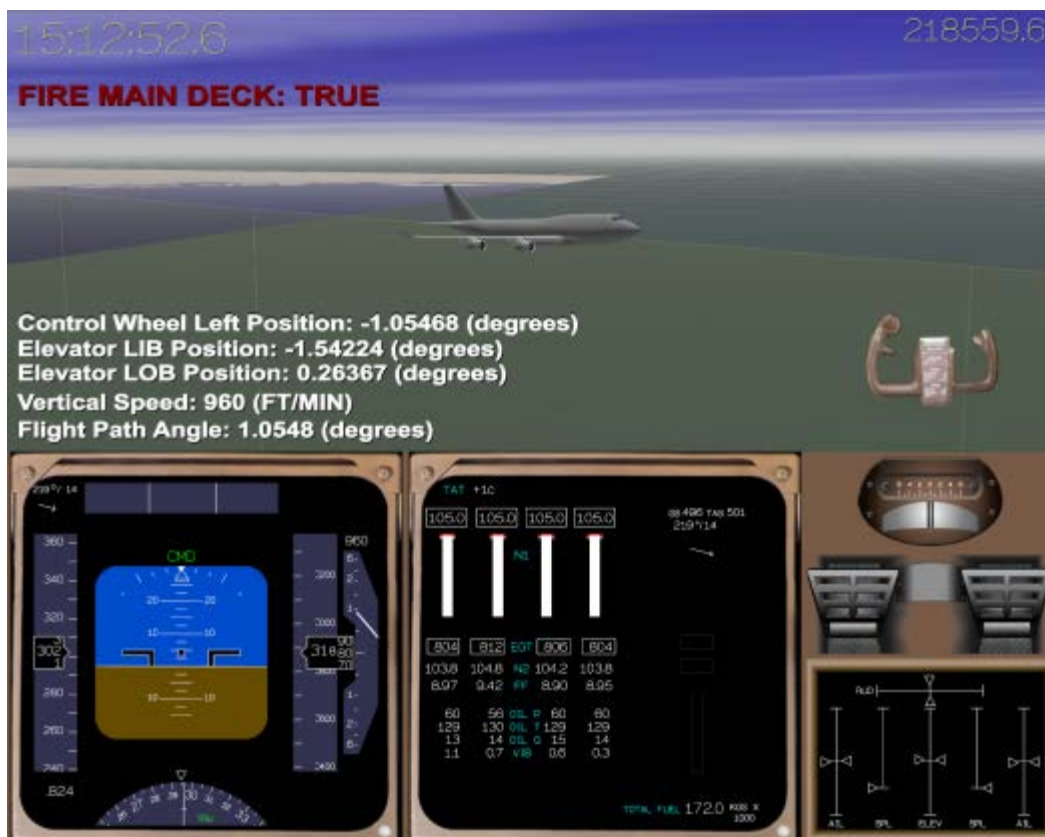
Just prior to reaching the selected altitude of 32,000 ft at 15:12:53 the master warning light illuminated and the fire warning bell sounded.

The master warning coincided with a DFDR discrete signal for fire on the forward main deck.

Figure 38: Fire Audible Alarm - 15:12:53 UTC

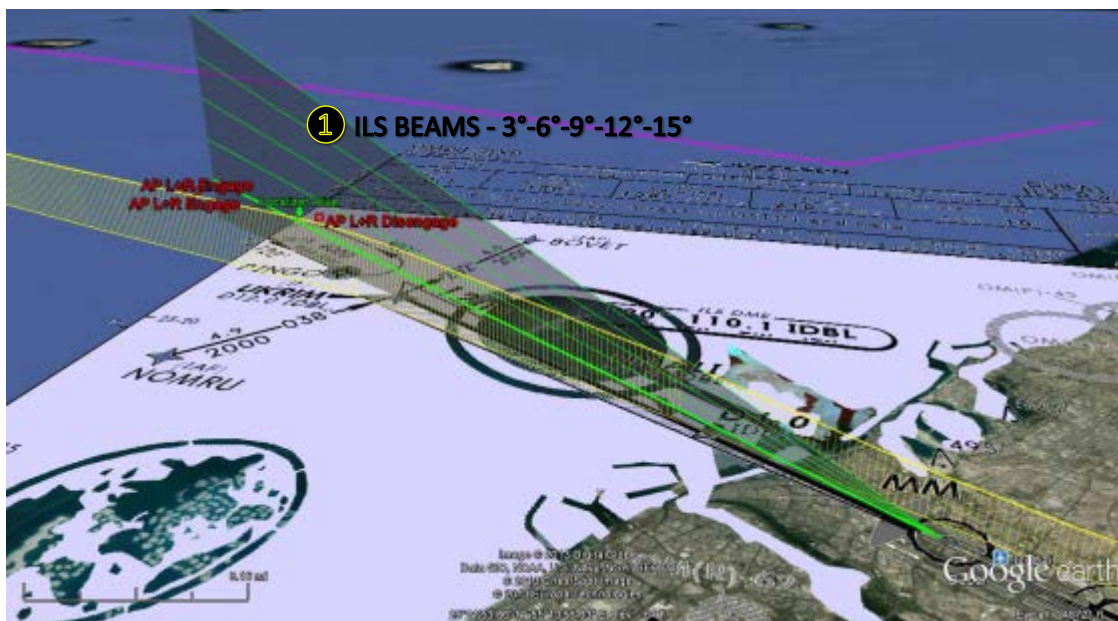
The glide slope (G/S) deviation parameter goes from negative to positive at this time<sup>①</sup>. This indicates that the aircraft was passing from below to above the beam. Based upon the distance from the Runway

12L glide slope transmitter (at DXB) and the altitude of the aircraft, the beam that was crossed was the 3 degree beam. G/S mode was not armed at this time.

Figure 39 DXB RWY 12L ILS Intercept

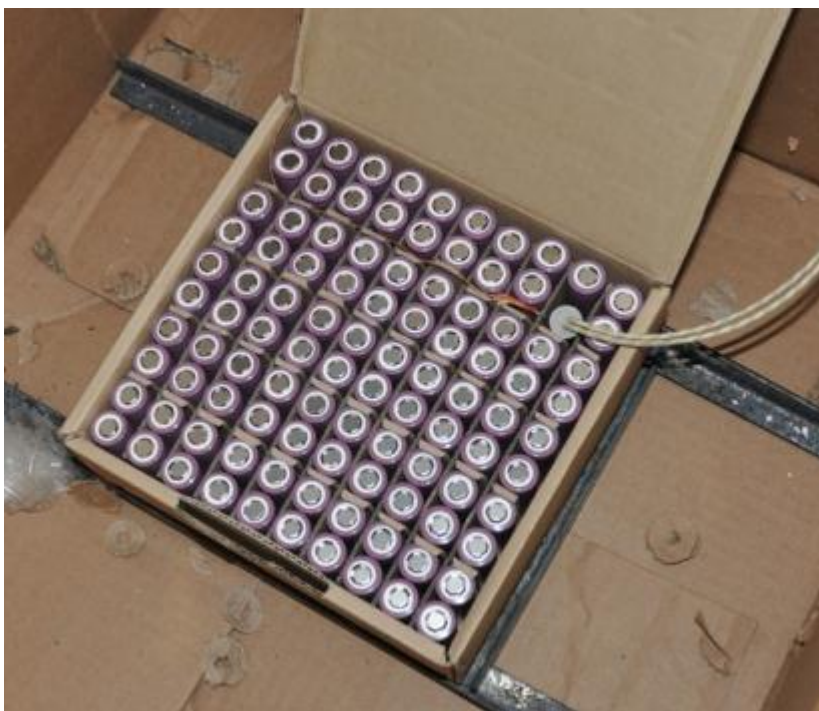
Figure 86: Box of batteries with cartridge heater in place (circled in red)

To simulate the case of batteries being the cause of the fire and self-igniting, a 250-watt cartridge heater was used to simulate a battery going into thermal runaway. One cell in the corner of the box of 100 batteries was replaced by the cartridge heater (figure 12). In addition to the batteries, the fire load for each of the two tests included 18 cardboard boxes each containing 2.5 lb of shredded paper inside, arranged in a 3 x 3 array two levels high (figure 13). Each cardboard box was an 18" cube. The box of batteries was placed inside the cardboard box (and covered with 2.5lb of shredded paper) at the center of the top level of boxes in the array. The additional fire load was used to observe the battery thermal runaway spread to the rest of the combustibles and to determine if the presence of batteries in the fire load had any measureable effect. For reference, two control tests were conducted using 18 boxes and no batteries. Those fires were initiated by an electric match inside the cardboard box at the center of the top level of boxes in the array, just as in the tests that included the box of batteries.

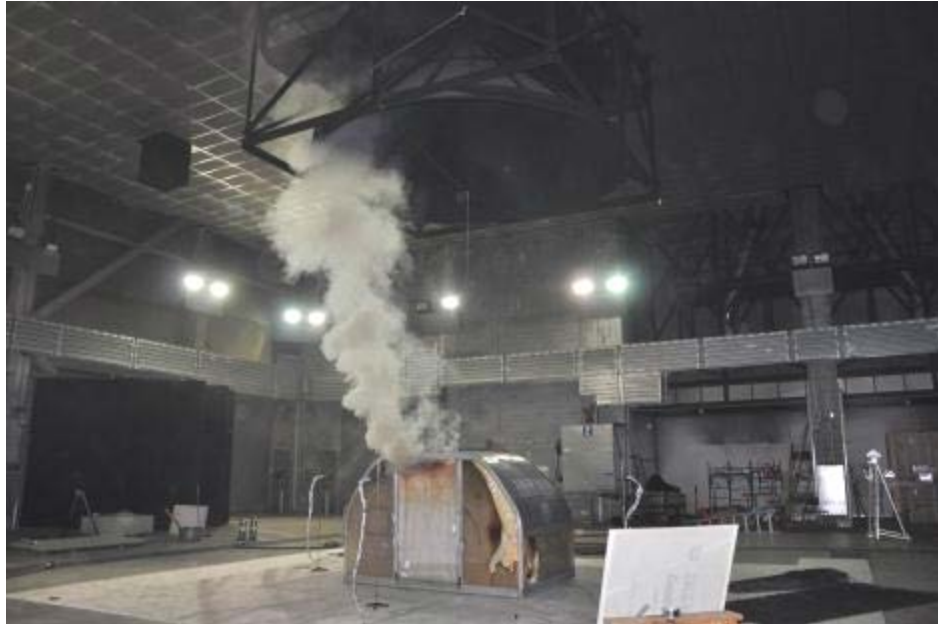
Figure 91: Smoke exiting above roll-up door on A2N type container

The results from both tests were in good agreement with each other. The peak energy release rates were 3.6 MW and 3.7 MW and the total energy released was 1530 MJ and 1690 MJ for tests 1 and 2, respectively. With regard to the smoke generation and its ability to exit the container, the observations made are noted on the graphs depicting the energy release rate of each test (figures 18 and 19). The first signs of smoke were observed to be exiting from the top portion of the roll-up door as expected. Two noteworthy time intervals are of particular importance. The first is the time between a fire being established inside the container and smoke beginning to exit the container in sufficient quantity to trigger an alarm, 199 seconds and 150 seconds for tests 1 and 2, respectively. The second is the time interval between the fire becoming detectable and the time to reach peak energy release rate, 450 seconds and 630 seconds for tests 1 and 2, respectively.

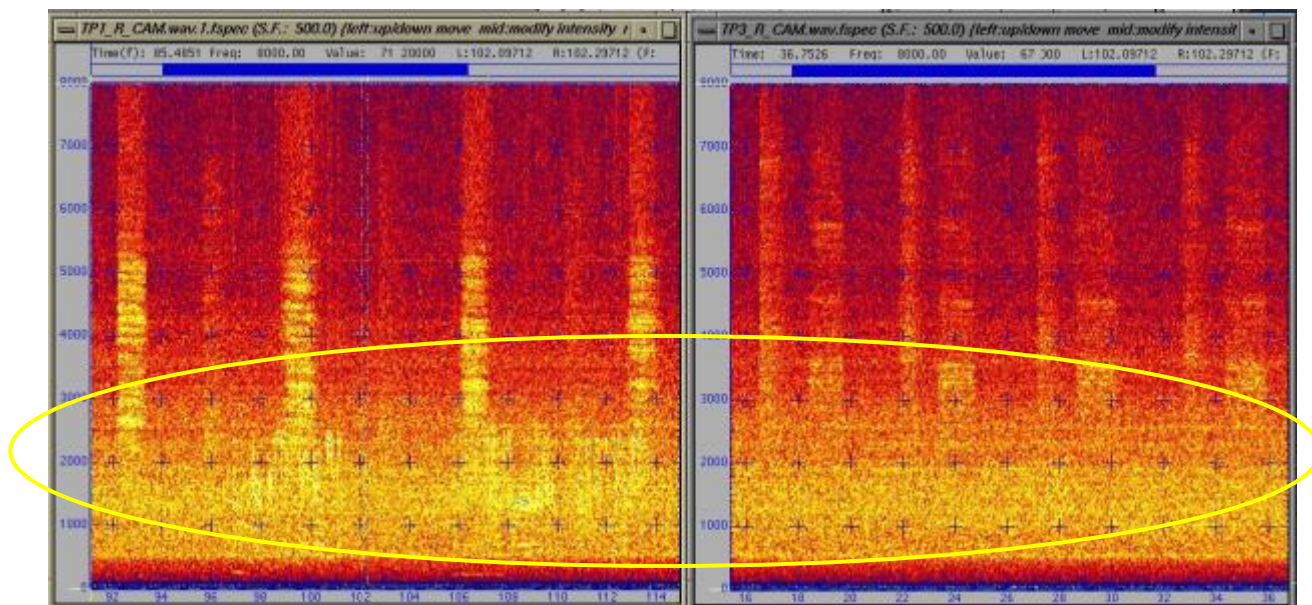
Figure 109 - Spectrogram of CAM - Test points 1 and 3, During Flight

In flight, this characteristic is much more difficult to discern, due to the background ambient noise in the cockpit. The area highlighted in Figure 108 shows the background noise during flight is too loud to see the lower frequency range of the inspiratory noise. As a result, this characteristic was not suitable to differentiate between mask modes.

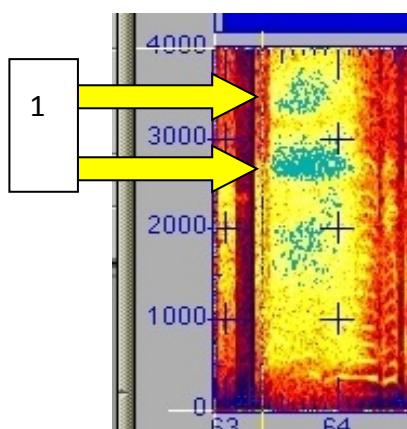
Figure 110 – Spectrogram of Inspiratory Noise from Mask Microphone Audio

The auditory review of the mask microphone audio revealed that the breath noises did not sound significantly different between the two mask modes. However, the sound spectrum analysis found a unique characteristic in the audio that differentiates one mask mode from the other. Figure 109 shows a spectrogram of the inspiratory noise from a single breath, as recorded from the oxygen mask microphone.

The audio from the mask microphones exhibits characteristic “bands” of energy during inspiratory breaths (light blue regions labeled 1 and 2 in Figure 109). These bands are a concentration of relatively higher sound energy within certain frequency ranges. The height of the bands (range of frequency) and total number of bands seems to vary, and may be affected by the overall loudness of the breath sound itself. However, two of these bands are present in all segments of audio that were examined (labeled 1 and 2 in Figure 109). The unique characteristic is the “center” frequency of Band 2. The band height (total frequency range) can vary, but the center of the band appears to be unique to the mask mode. In
