FINAL
KNKT.07.02.05.04

Aircraft Accident Investigation Report

**PT. Adam SkyConnection Airline (Adam Air)
Boeing 737-300 ; PK-KKV
Juanda Airport, Surabaya, East Java
Republic of Indonesia**

21 February 2007

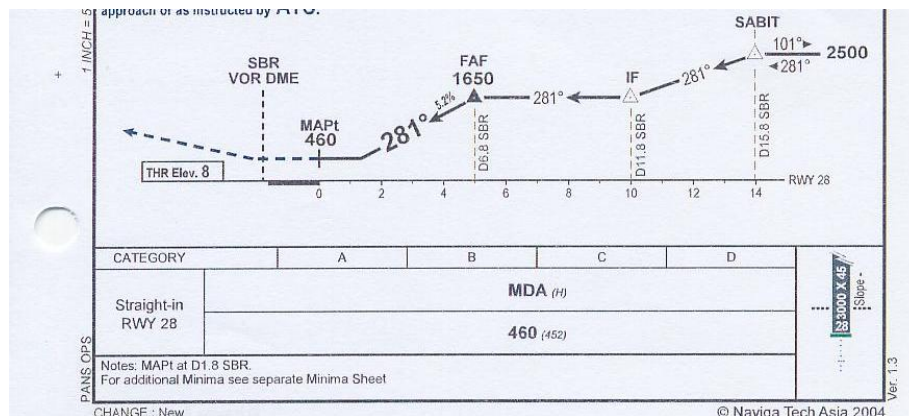
Figure 11: Descend profile VOR/DME approach runway 28 Surabaya

The flight crew discussed about initial approach altitude and approach descend point. This showed that both pilot did not familiar with the VOR/DME approach profile.

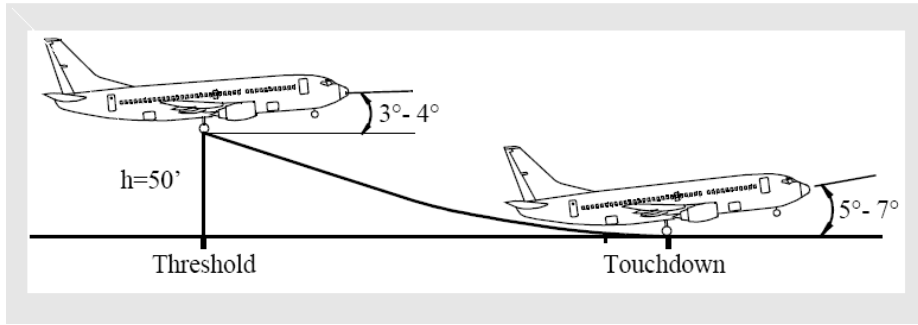
Figure 13: The Boeing recommendation for aircraft attitude during approach

The Boeing FCTM also recommended the attitude of the aircraft during the approach. It is recommends that during cross the threshold, the aircraft attitude is between 3-4 degrees up. While flare out for touchdown, the aircraft attitude is between 5-7 degrees up.

The rate of descent, the pitch attitude and late of flap selection to 40 were the indication that a stabilized approach criteria was not met. According to the Boeing FCTM, the go around should be initiated.
