**NATIONAL
TRANSPORTATION
SAFETY
COMMITTEE**

Aircraft Serious Incident Investigation Report

AIRBUS A320-321

PK-YVE

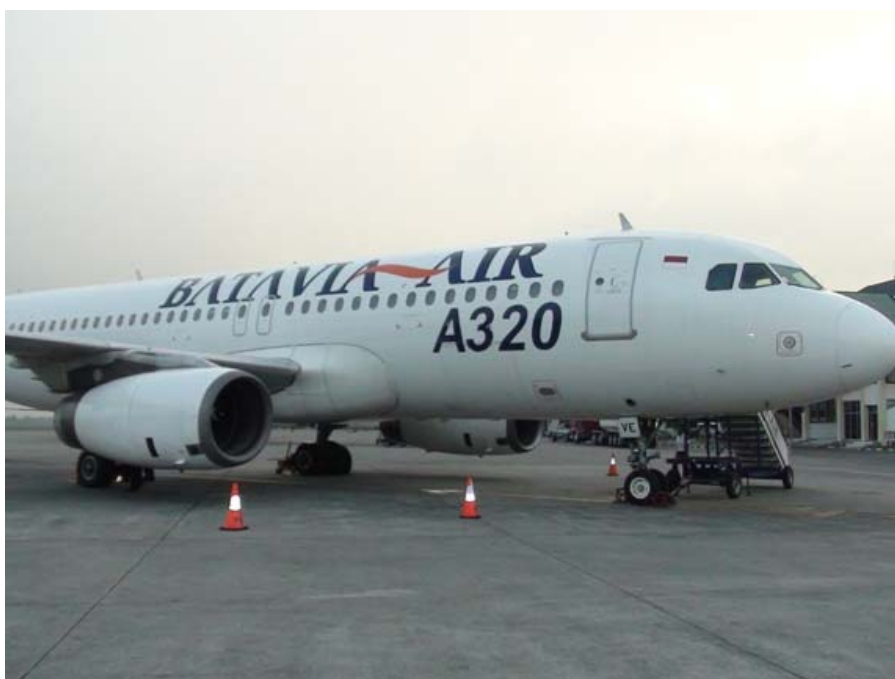
Figure 1: PK-YVE, Batavia Air Airbus A320 at Medan on 2 June 2008

The aircraft touched down towards the departure end of the touch-down area of runway 05 at Polonia Airport, Medan at 03:04. After a landing run of 41 seconds, it stopped on the runway adjacent to taxiway 'D', approximately 1,200 meters from the estimated point of touch down. Three main-wheel tires and two main wheels were substantially damaged.
