Aircraft Serious Incident Investigation Report

KNKT/06.06/08.02.37

PT. Adam SkyConnection Airline

B 737-329

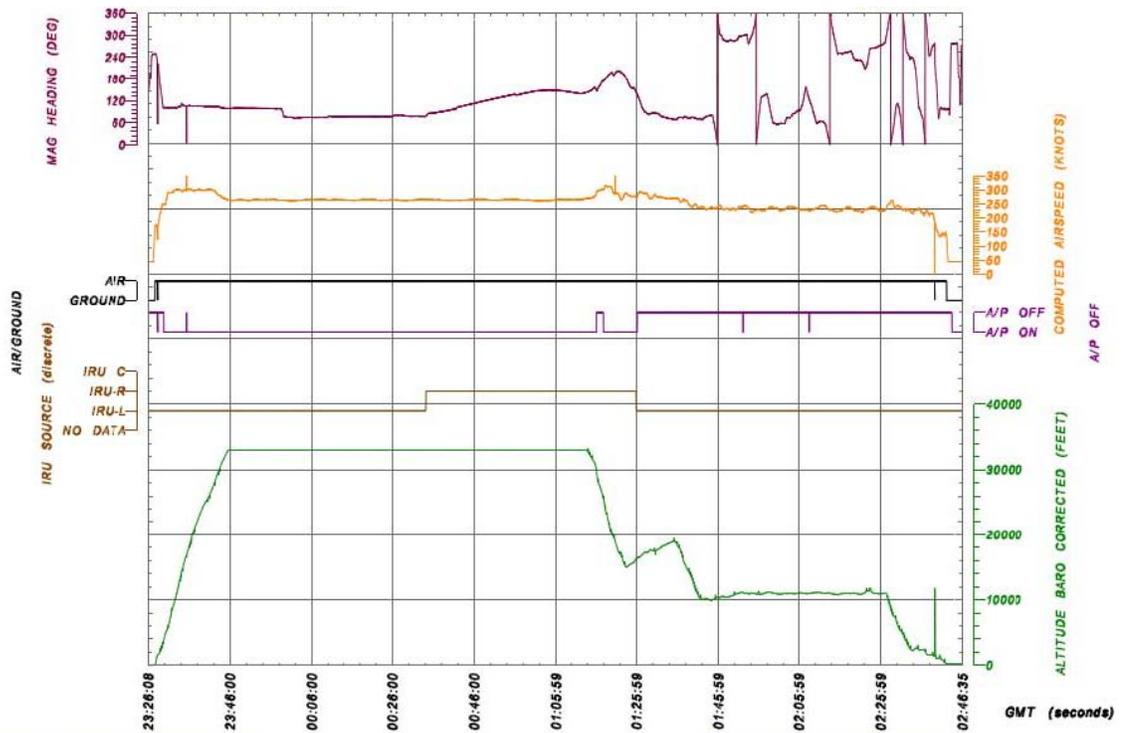
Figure 7: FDR plot between 23:26:08 and 02:46:35

While passing 25,000 feet, the pitch command warning appeared, followed by a roll command. The autopilot then disengaged uncommanded. The PIC subsequently flew the aircraft manually. The pilots then referred to the standby compass and found that the aircraft's heading was 230 degrees.
