AIRCRAFT ACCIDENT INVESTIGATION REPORT

ASIANA AIRLINES INC.

H L 8 2 5 8

**PASSENGER INJURY BY THE SHAKING OF THE AIRCRAFT
ASIANA AIRLINES INC.
AIRBUS A330-300, HL8258 (THE REPUBLIC OF KOREA)
AT AN ALTITUDE OF APPROX. 40,000 FT, OVER MATSUE CITY,
SHIMANE PREFECTURE, JAPAN
AT AROUND 15:17 LOCAL TIME, AUGUST 21, 2012**

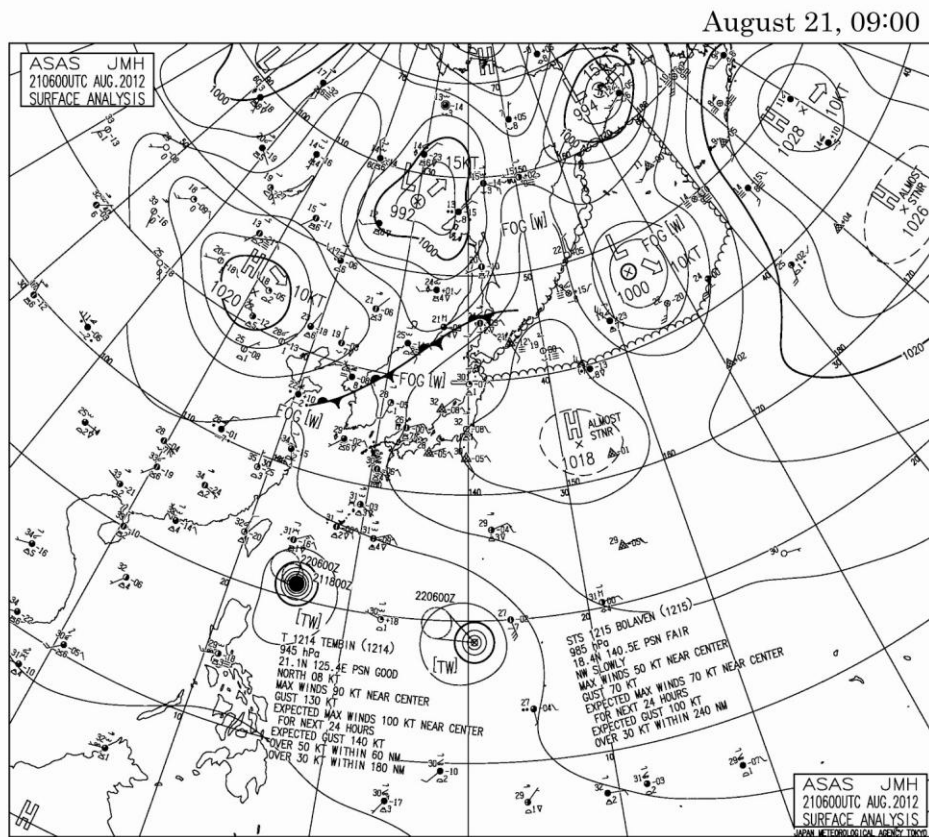
Figure 5: Asia Surface Analysis Chart

moisture-laden warm air*⁶ moving around the edge of the high-pressure area over the sea to the east of Japan were flowing from the Pacific Ocean side into the West Japan region, the atmospheric conditions over all areas of West Japan became unstable making it easier for cumulonimbus to be generated.

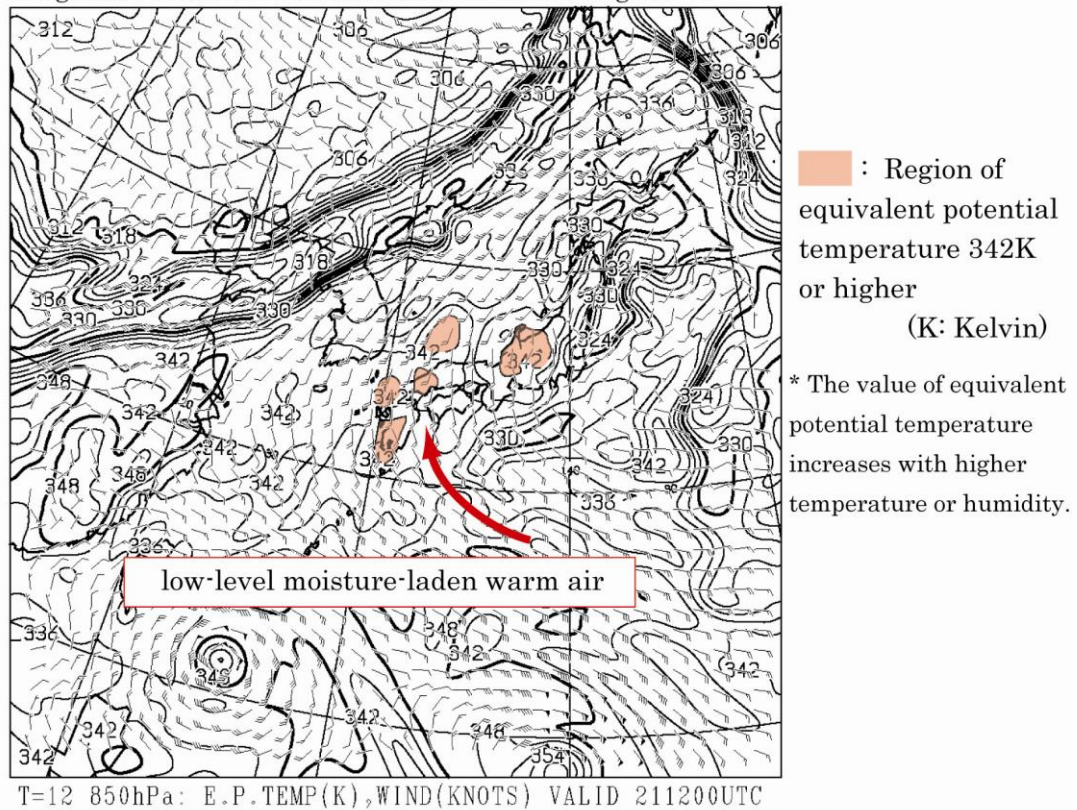
Figure 7: Wind and Equivalent Potential Temperature Prognostic Chart (850 hPa)

*⁴ The "Wind and Equivalent Potential Temperature Prognostic Chart (850hPa)" is a prognostic chart indicating the extent of wind and warm, humid air currents around an altitude of 1,500 m.

Prognostic chart for 12 hours after 09:00 on August 21

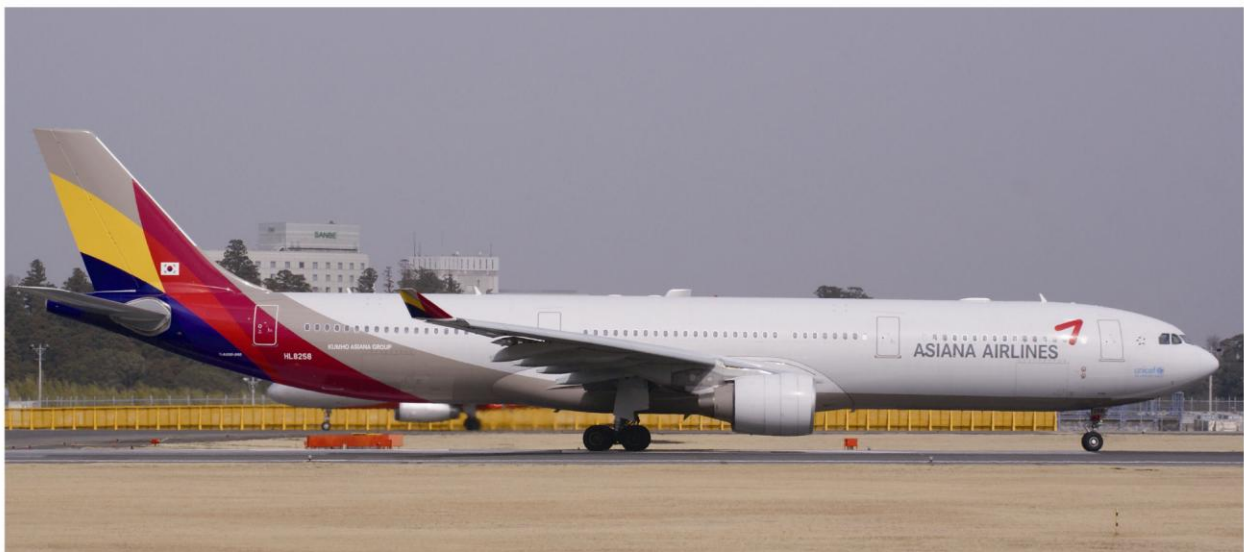
Photo: Accident Aircraft

After landing, the Aircraft underwent a special inspection which is required after encountering severe turbulence or exceeding M_{MO} ; however, no damage or anomalies were found.
