**AIRCRAFT ACCIDENT
INVESTIGATION REPORT**

**JAPAN AIRLINES CO., LTD.
J A 6 5 4 J**

May 28, 2015

CABIN ATTENDANTS INJURIES
BY THE SHAKING OF THE AIRCRAFT
JAPAN AIRLINES CO., LTD., BOEING 767-300, JA654J
AT AN ALTITUDE OF APPROXIMATELY 16,000 FT
ABOUT 95 KM SOUTHEAST OF
GIMPO INTERNATIONAL AIRPORT (KOREA)
AT 17:33 JST, SEPTEMBER 12, 2014

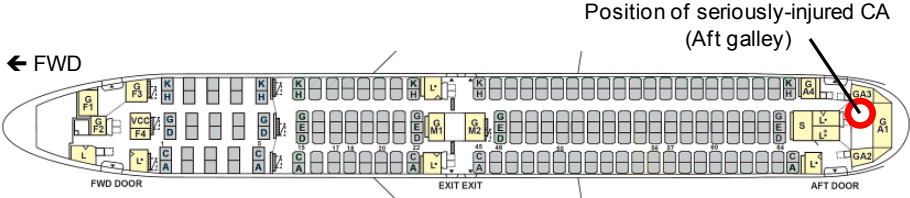
<p>preparing for landing. Since shaking of the aircraft gained its momentum from around 17:28, CAs and interpreters in the aft galley took their seats temporarily although the seatbelt sign was not lit on. When they resumed their work after the shaking subsided, they suddenly encountered a violent vertical shaking, by which cabin crewmembers were thrown into the air to hit the ceiling and one of them fell onto the floor on her back. As a result, she was seriously injured.</p> <p>The atmosphere being stabilized after clearing clouds, the PIC turned on the seatbelt sign at 10,000 ft as usual and continued descent. The aircraft landed at Gimpo International Airport at 17:51.</p> <p>The accident occurred at 17:33 on September 12, 2014, near GUKDO, about 95 km southeast of Gimpo International Airport (37°01'43" N, 127°38'05" E), at an altitude of approximately 16,000 ft.</p> <p>(See figure 1 and 2)</p>
