**AIRCRAFT SERIOUS INCIDENT
INVESTIGATION REPORT**

**ALL NIPPON AIRWAYS CO., LTD.
J A 8 6 7 4**

Operator: ALL NIPPON AIRWAYS CO., LTD.
Type: BOEING 767-300
Registration number: JA8674
Type of serious incident: ENGINE INTERIOR DAMAGE
Time and date of outbreak: AT 09:19 , JULY 8, 2011
Occurrence Point: AT AN ALTITUDE OF APPROX. 8,500M
ABOUT 79KM TO THE NORTHWEST
OF TOKYO INTERNATIONAL AIRPORT

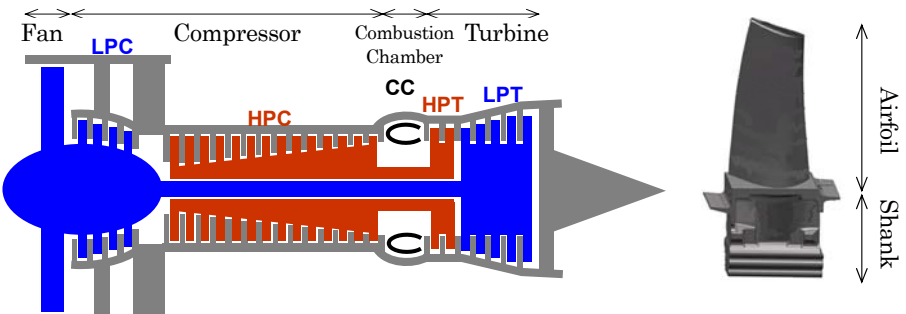
<p>2.2 Injuries to Persons</p>	<p>None</p>
<p>2.3 Damage</p>	<p>(1) Extent of Damage: Minor damage (major damage to inside of the engine)</p> <p>(2) Damage to inside of the Engine</p> <p>The High Pressure Turbine (hereinafter referred to as “HPT”) is composed of two stages. Out of 74 second stage HPT blades, the blade 69 (hereinafter referred to as “the Blade”) was separated at a distance of 1.3 inches (1 inch = about 25.4mm) from the bottom in the shank and lost. Other blades exhibited damage on the blade tips.</p> <p>The Low Pressure Turbine (hereinafter referred to as “LPT”) is composed of five stages. The LPT blades exhibited damage along the full axial length of the LPT module.</p> <div style="text-align: center;">
