Investigation Report

Type of Occurrence:	Accident
Date:	4 October 2007
Location:	Düsseldorf
Aircraft:	Airplane
Manufacturer / Model:	Airbus / A330-322
Injuries to Persons:	None
Damage:	Aircraft severely damaged
Other Damage:	Minor damage to buildings and outdoor facilities
Information Source:	Investigation by BFU
State File Number:	BFU 1X002-07

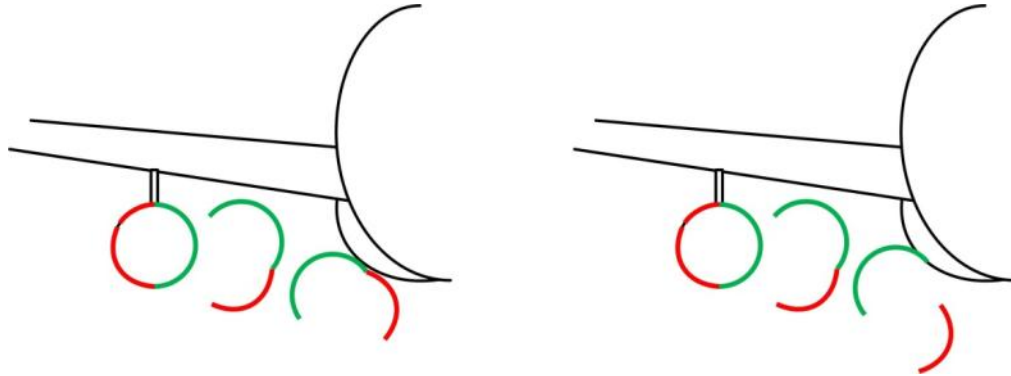
A. Both doors remain connected with the latches until they impact the belly fairing. In this case the hooks would still be connected with the clevises. The hooks would not

have impacted the belly fairing individually. This does not correspond with the part distribution found on the belly fairing.

Possible movements of the cowling

left: 1. both doors remain connected
