# Investigation Report

Type of Occurrence:	Serious incident
Date:	15 August 2011
Location:	Düsseldorf
Aircraft:	Airplane
Manufacturer / Model:	Airbus Industrie / A330-322
Injuries to Persons:	None
Damage:	Minor damage to aircraft
Other Damage:	None
Information Source:	Investigation by BFU
State File Number:	BFU 5X007-11

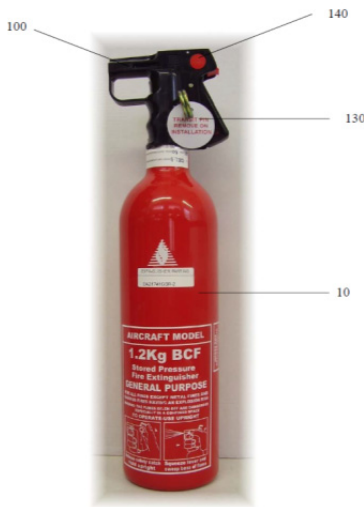
The cabin crew members used a fire extinguisher (P/N BA21741GSR-2) to fight the fire. The fire extinguisher was filled with 1.2 kg BCF (Halon 1211).

Fire extinguisher (example)
