*Accident
on 24 March 2001
at Saint-Barthélemy (971)
to the DHC-6-300
registered F-OGES
operated by Caraïbes Air Transport*

REPORT
f-es010324a

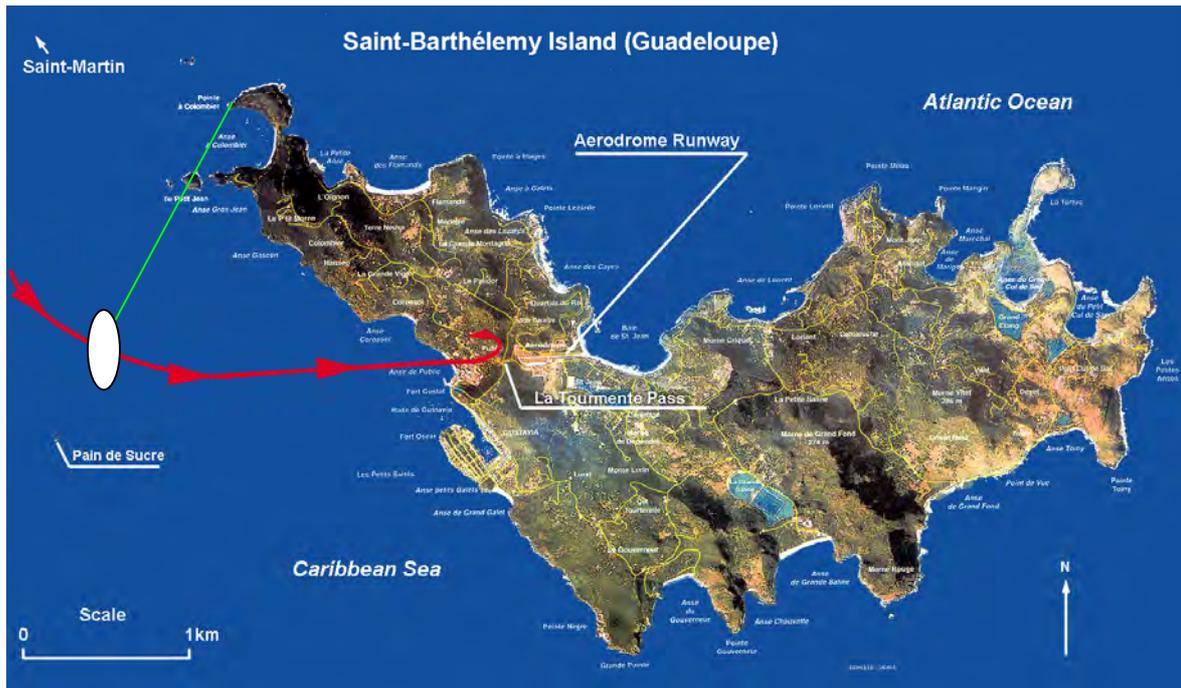
Orientation of the last image on the film

One of the last images on the usable part of the film enabled F-OGES to be situated, by aligning the Pointe à Colombier and Petit Jean island on an aerial photo, on the last turn of the approach, across the Pain de Sucre. Taking into account the distance from the La Tourmente pass (1.3 NM), there remained about one minute of flight before the accident.

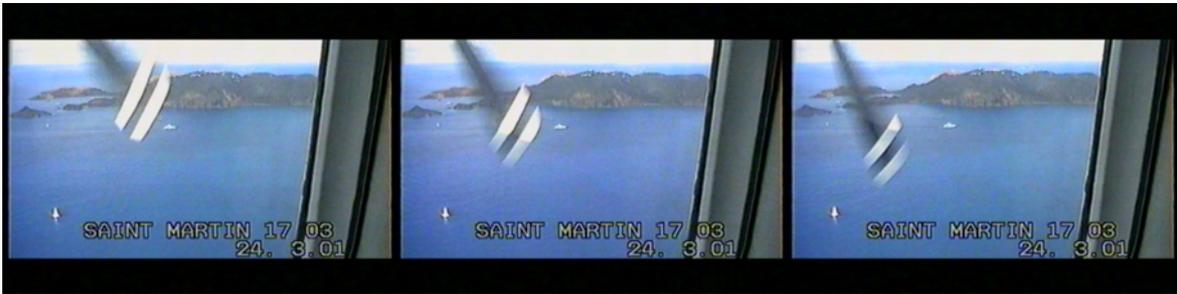
Analysis of the video tape where the left propeller is visible enabled the green curve to be drawn: there are twenty-five images per second; it is possible to determine on each the position of the blades and thus the number of passages per second. Three photos taken from the film are presented below to illustrate the calculation.

Overlaying the green and blue curves shows that the latter corresponds to the left propeller.

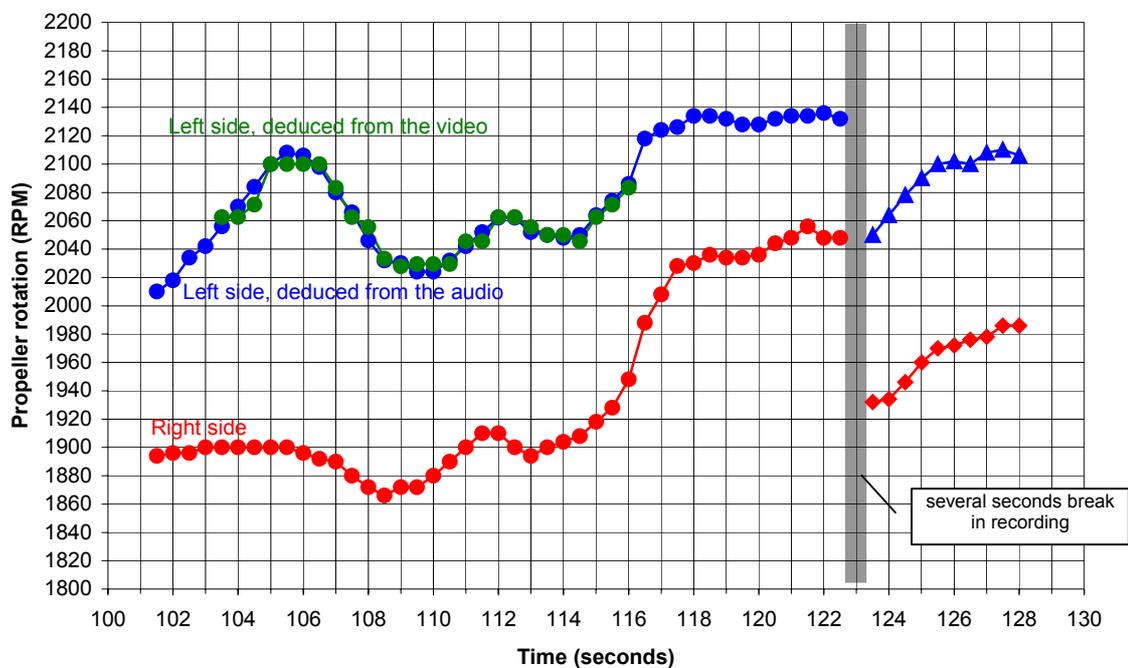
The rotation speeds of the propellers during flight TX 1501, expressed as a percentage of the reference rotation speed as defined by the manufacturer, are represented on the following graph. The discontinuities between the points correspond to the ends of each recording.

The asymmetry between the two propellers during the approach phase was around 9%, which is consistent with normal use (see following). An increase in RPM of the order of 6% to 8% was also noted.
