Final report RL 2016:11e

Accident in Oajevágge, Norrbotten County, Sweden on 8 January 2016 involving the aeroplane SE-DUX of the model CL-600-2B19, operated by West Atlantic Sweden AB.

File no. L-01/16

12/12/2016

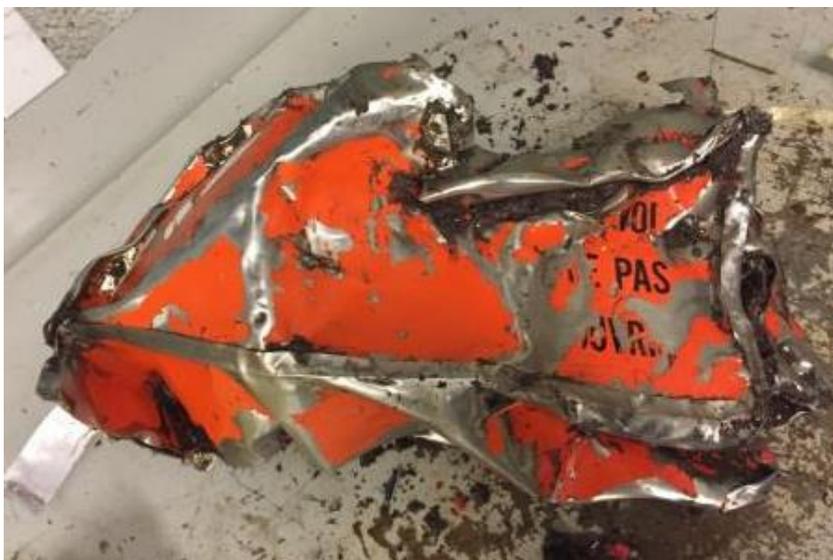
Figure 14. DFDR-unit.

The aeroplane was equipped with a flight data recorder (DFDR, Digital Flight Data Recorder) and a CVR (Cockpit Voice Recorder). The units were heavily demolished and have been recovered. The memory unit had separated from the CVR chassis. Both units including the CVR memory unit were transported by SHK's staff to the French accident investigation authority, BEA, for readout.

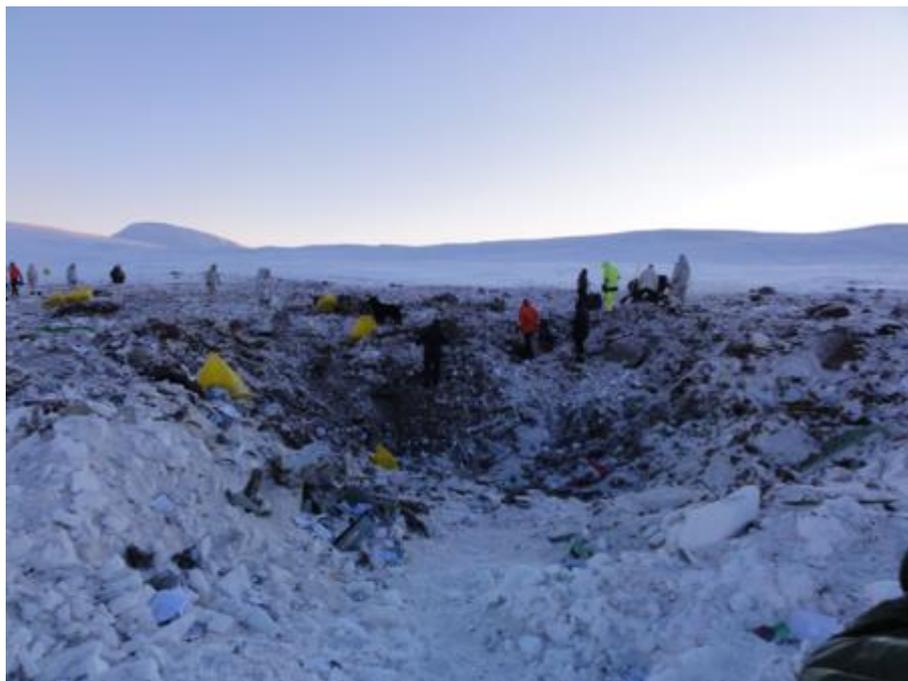
During the first visit at the accident site, about 3.5 tons of debris, equivalent to more than 25 percent of the basic empty mass of the aeroplane and about 1 ton of cargo was recovered for further investigation (figure 18).

Figure 18. First visit at the accident site.

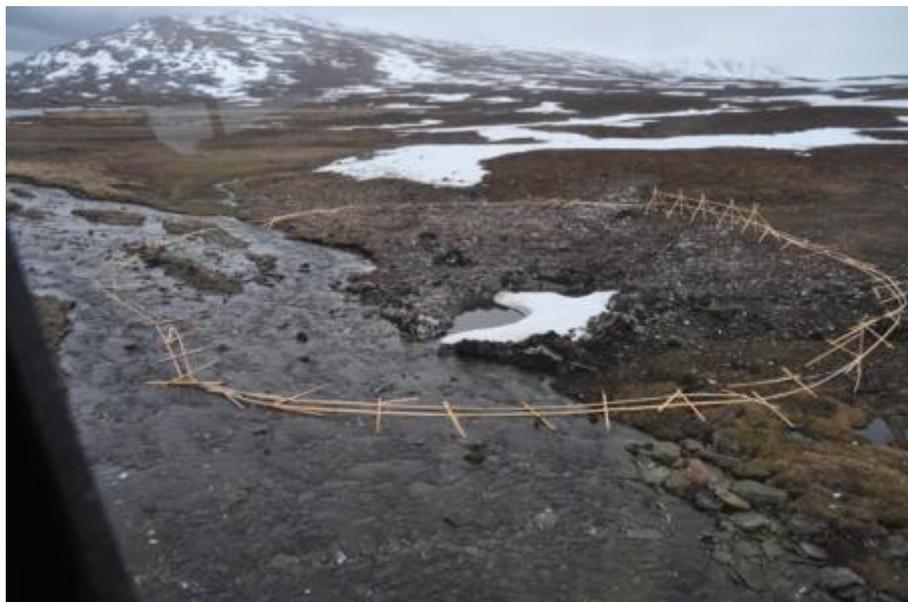
At the second visit during summer (figure 19) approximately 9.5 ton of debris from the aircraft and the cargo was recovered and examined.

Figure 19. Second visit at the accident site.
