ACCIDENT REPORT

occurred to the Boeing B737-800AS aircraft
registration marks EI-DYG
Rome Ciampino airport
November 10th 2008

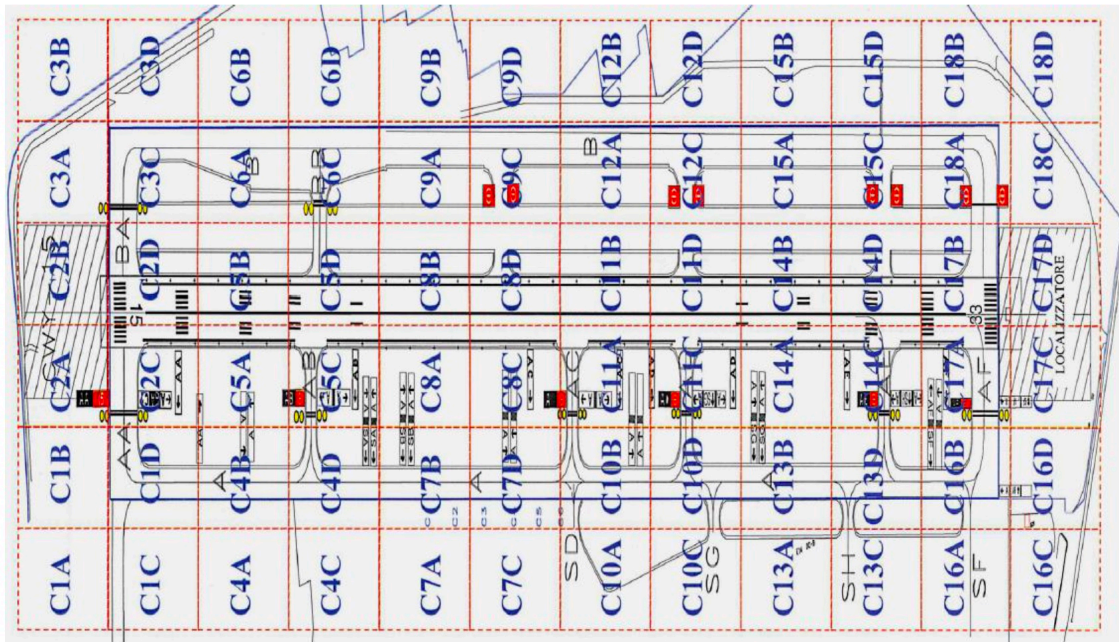
On the evening of the day preceding the incident, a scheduled inspection took place (sunset) with starting time 16.25 'and closing time 17.00', which had detected the presence a number of about 1000 starlings, placed on the grass, which affected the C2B and C3A and 300 starlings placed on the grass in the C1B and C1A sectors.

Picture 10 : birds inspection grid

While the aircraft was in this position, they took off from a point to the ground to about 50 m from the runway threshold, corresponding to the C2A and C2B areas of the grid shown in figure 10, about 300-400 small birds, which have hit in both the front of the aircraft, both the engines of the same.

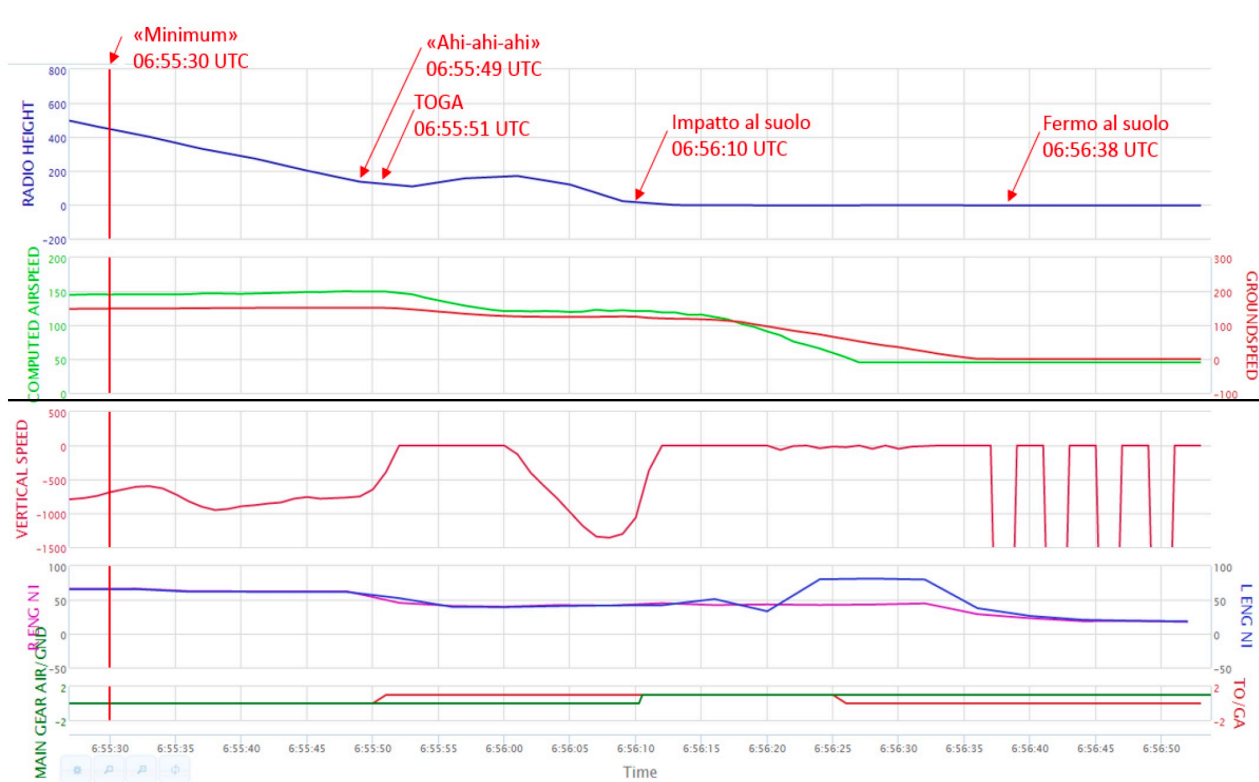
When the TO / GA was applied, the vertical speed has been further and more rapid reduction and the descent trajectory of the aircraft had a slight increase in the radial height (from 108 to 173 feet), up to 06.56'01 ".

After this time the aircraft resumed descent.

Picture 17 : N1 speed from MDA/DH to ground contact

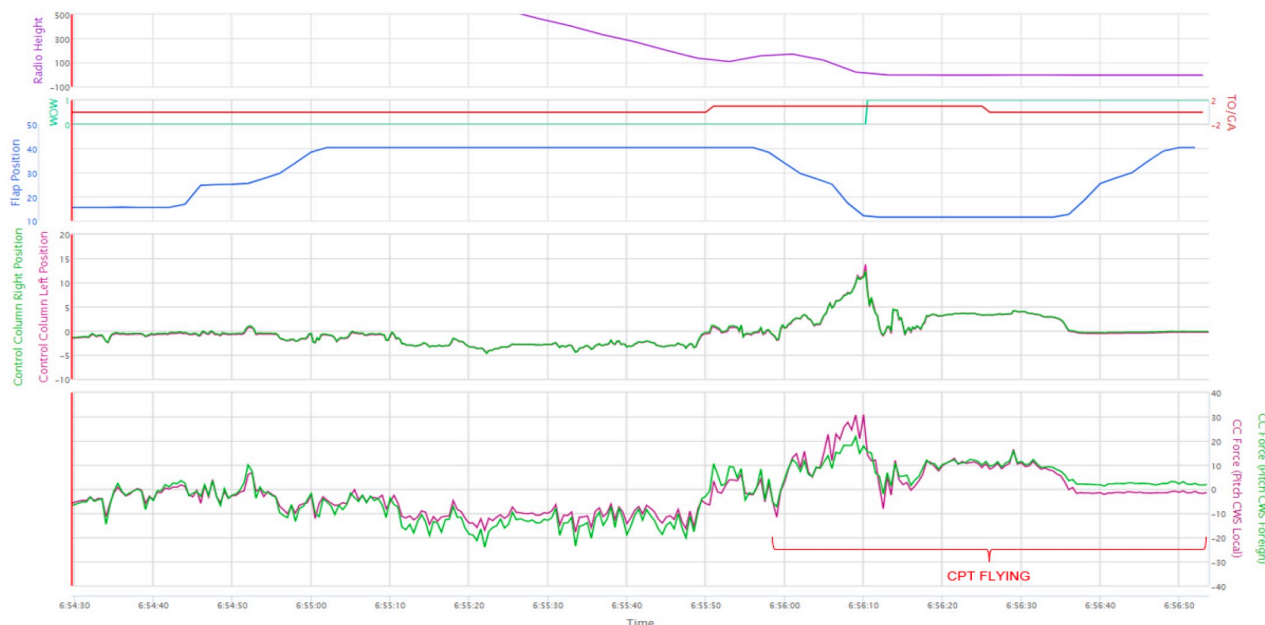
At 06.55'56 "the flap selection was commanded, from 40 ° to 10 °, a position that was reached at 06.56'12 ", with the aircraft on the ground.

From the FDR data it is clear that the commander has acquired control of the aircraft at 06.55'58 ", or 7 seconds after the activation of the TO/GA.

Picture 18 : Selection of Flaps and takeover of flight controls by PIC

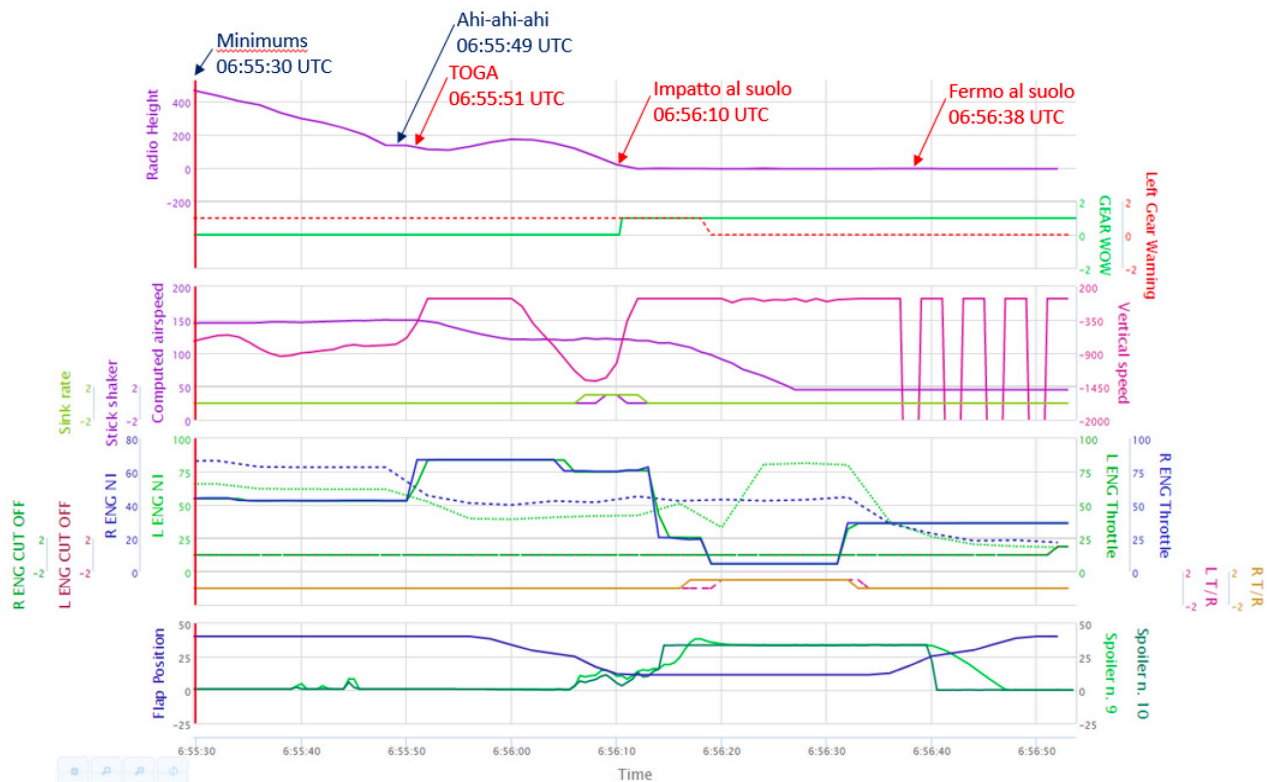
After the touchdown, at 06.56'10 "and up to 06.56'38", the plane has decelerated with the use of the brakes, the thrust reverse eng. 1 and spoilers. During the ground run, the activation of the warning related to the unsafe condition of the left landing gear is recorded.

With stopped aircraft, it was noticed the lowering of the flaps at 40 ° and the zeroing of the spoilers.

Picture 23 : flap movement, spoilers, and thrust reverser

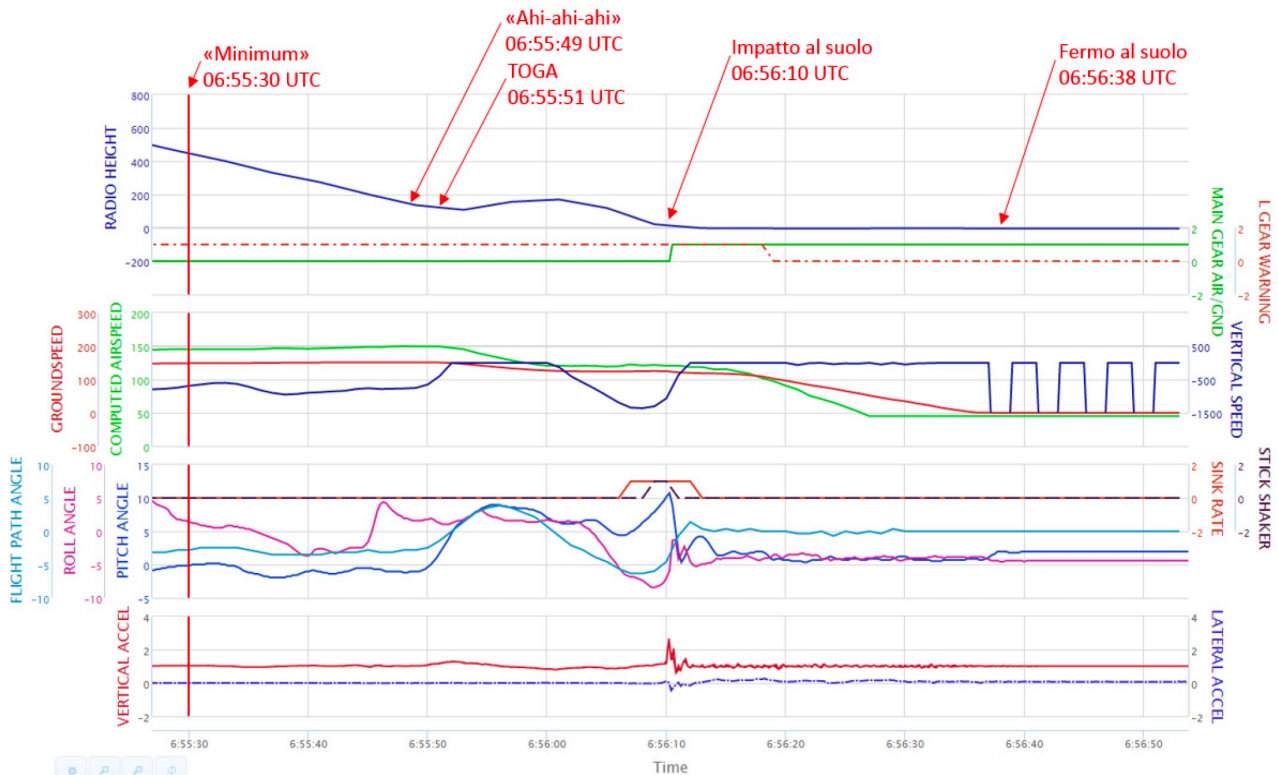
In the phase in which the flight path angle has changed from -3° to about $+5^{\circ}$, the pitch angle has changed from about -1° to $+9^{\circ}$, and then keep positive some degrees until the impact with the ground.

The magnetic heading of the aircraft was also characterized by excursions to the right and left with respect to the runway direction (150°), accompanied by excursions on the roll axis. The aircraft impacted the runway with a roll angle of about 6° to the left and a pitch of about 10° .

Picture 24 : pitch and deceleration data

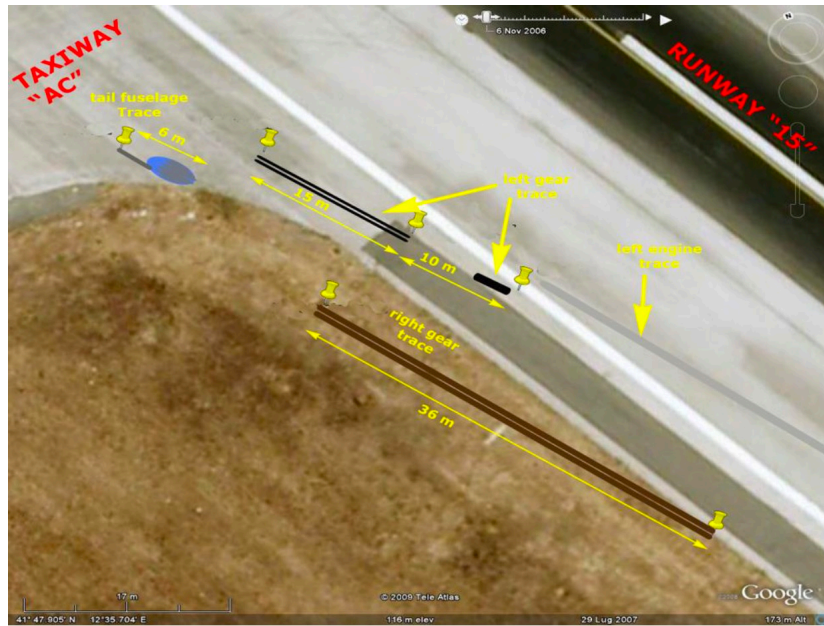
Photo 6 : overall traces of landing gear and tail

From all these traces emerges an angle of about 20° between the direction of the aircraft at contact with the runway and its axis.

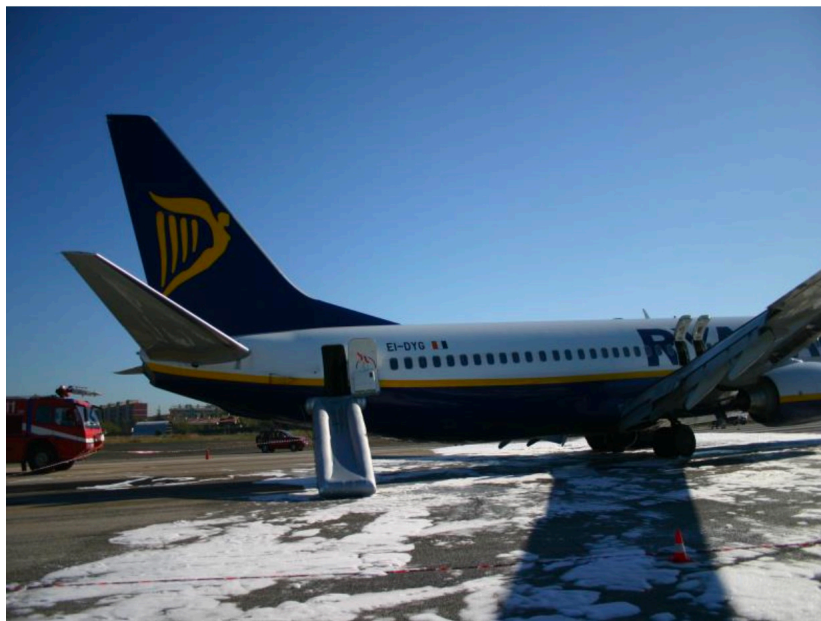
The right rear slide was deployed during the disembarkation phases of the passengers and crew.

Photo 9 : the slide of the right door deployed

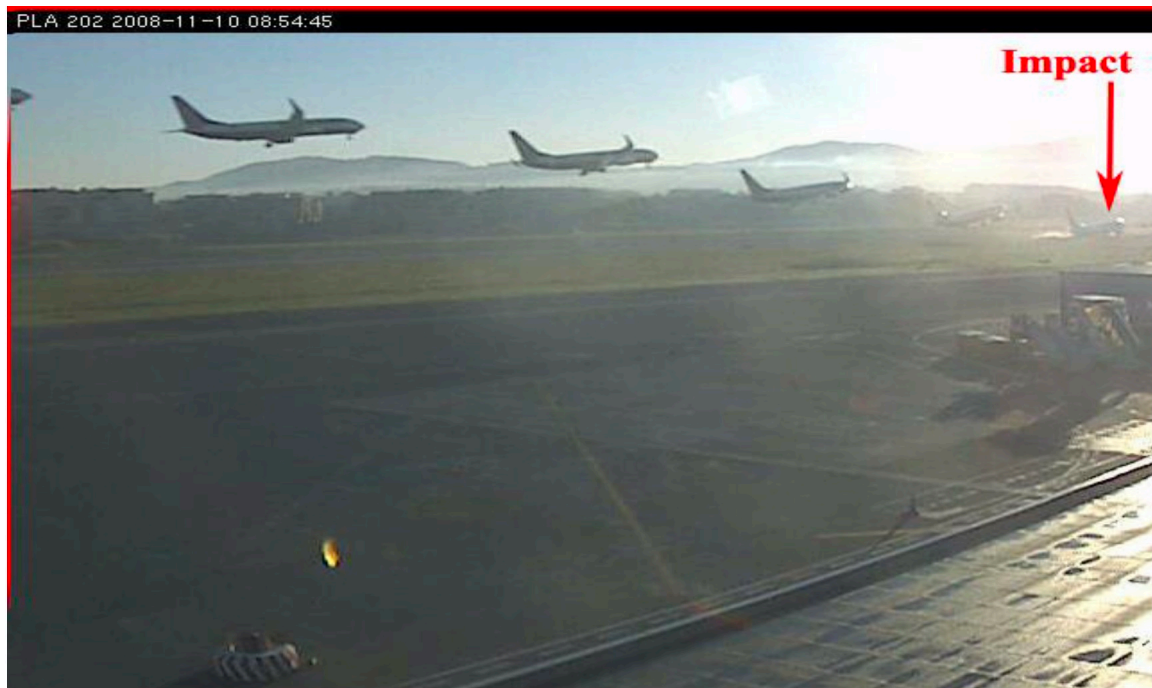
From the videos available from the airport cameras it was possible to acquire a series of useful frames to reconstruct the trajectory and final pitch of the aircraft up to impact with the runway.

Photo 21 : overlapping frames from the airport video camera

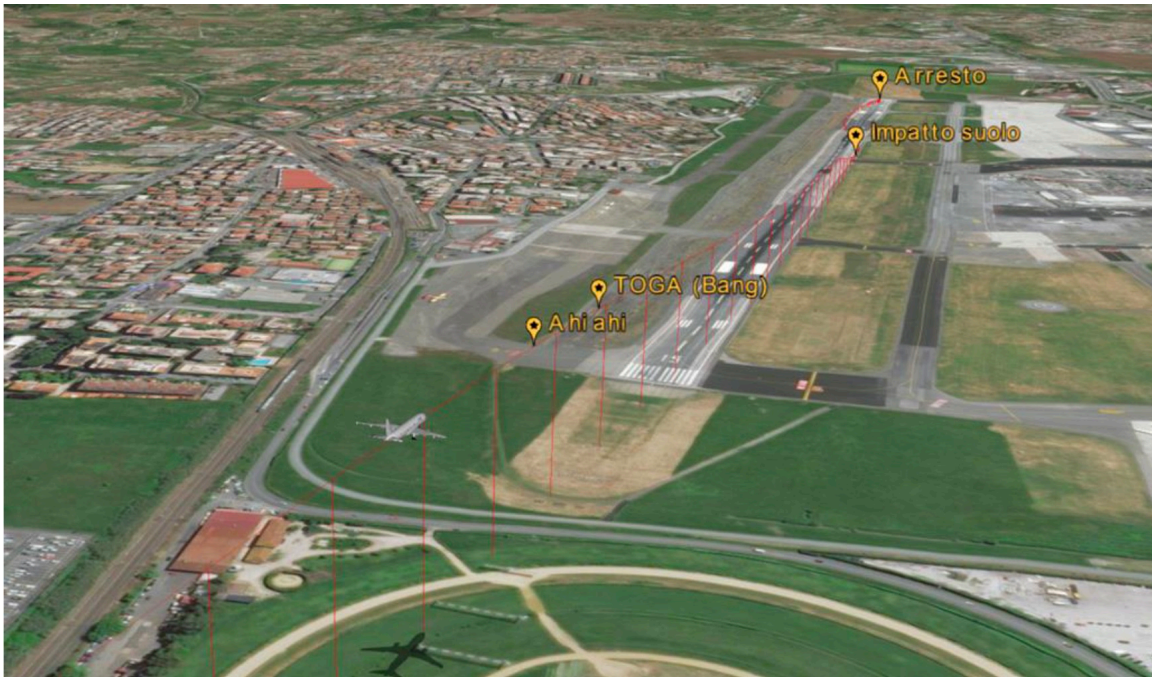
Picture 27 : ANSV reconstruction, the final trajectory of EI-DYG

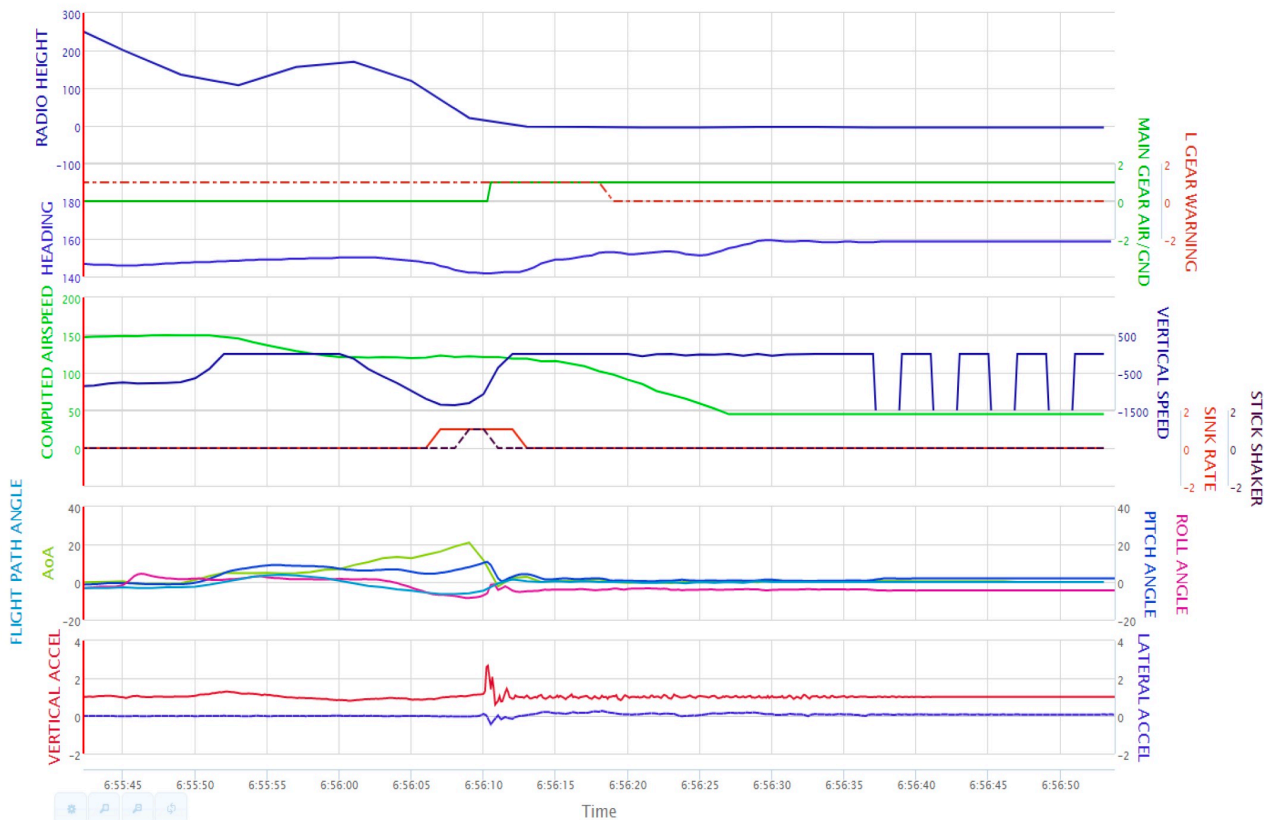
The aircraft, on impact, had a mass of 61.144 kg (134.800 lbs). Upon contact with the ground, a vertical acceleration of 2.66 g and a side of -0.45 g were recorded.

Picture 28 : aerodynamic parameters and accelerations at ground contact

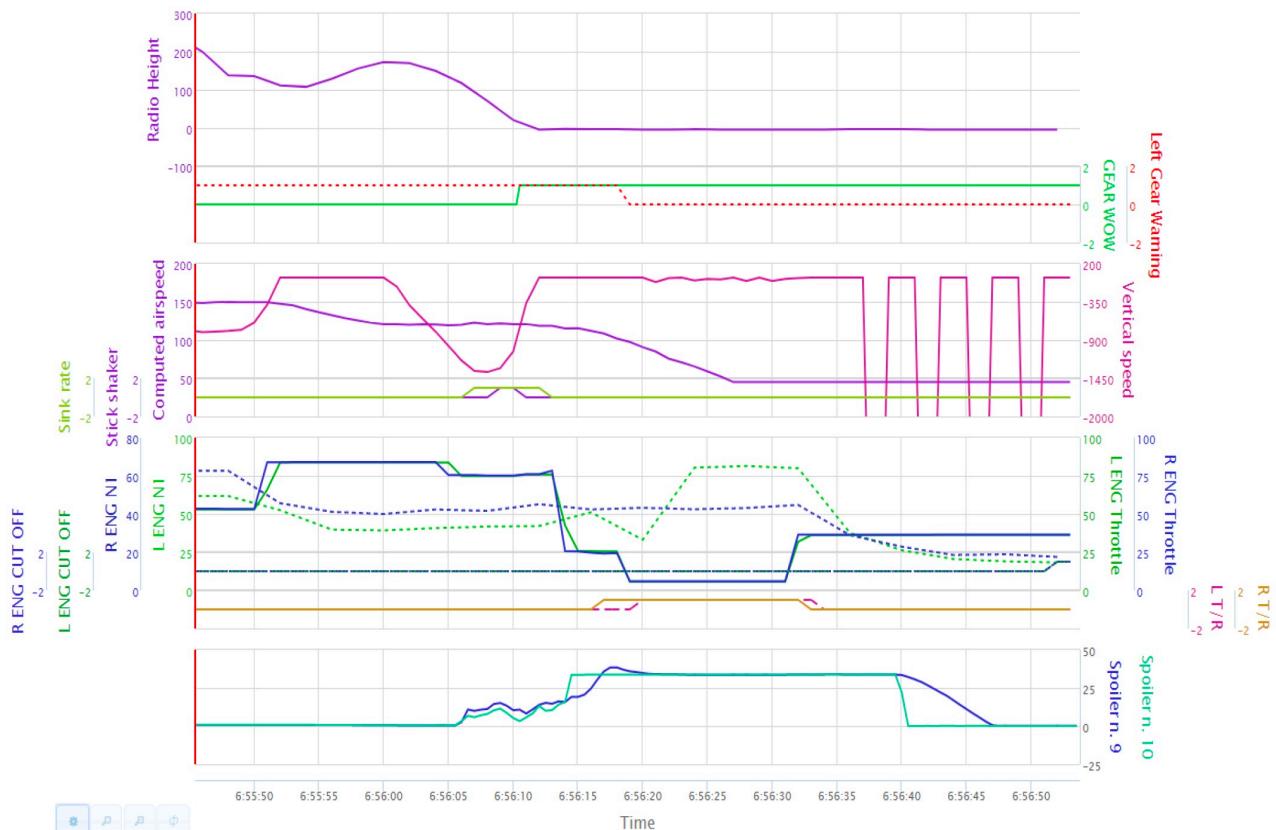
Picture 29 : engine parameters and thrust reverser activation

The maximum vertical speed changed from a value of 752 feet per minute at the moment of the activation of the TO / GA at a minimum value of 0 feet/minute in two seconds (06.55'52 ").

From this moment a progressive decrease of the speed and an increase in the angle of attack, which reached the values of 120.75 knots and 21 ° of AoA at 06.56'10 ", when the aircraft was at a radalt height of 21 feet.
19 seconds passed from TO/GA to ground contact.

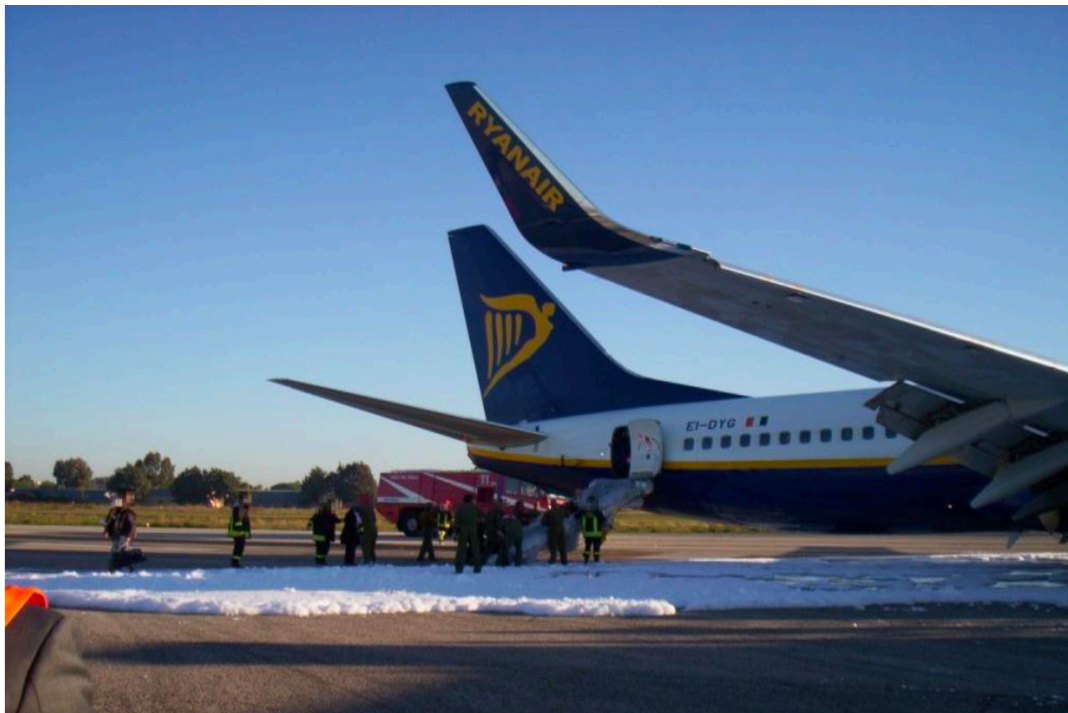
Photo 23 : passengers evacuating through the right rear door slide

In this circumstance assistant No. 3 reported having noticed the oxygen masks leaks and 3 of the 4 wing emergency exits opened, most likely by the passengers. Assistants No. 2 and No. 3 were instructed to return to the rear galley for providing any assistance, in case the evacuation continued through the rear doors of the aircraft. Assistants No. 2 and No. 3 were instructed to disarm, via intercom, by order of the Commander, the slide of the exit R2 and to open the door.

It was not possible to determine the number of passengers disembarked through the slide. The assistant reported in the statement to have noticed, at the time of opening of the door, the copious presence of foaming around the plane. He reported having noticed the wing emergency exits (left one and two right) open. He then noted, in the course of evacuation, aircraft instability, with movements both on the roll axis both pitching. He reported that passengers delayed evacuation operations in an attempt to take hand baggage and to take photographs.

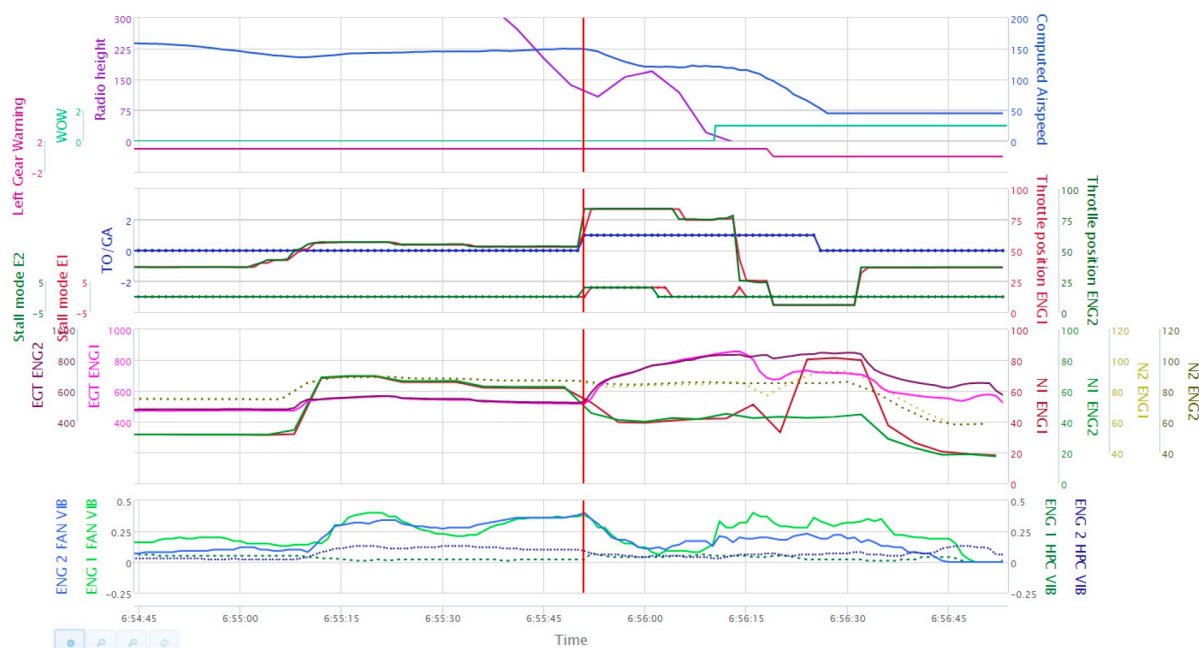
Picture 32 : engine vibrations before bird sighting and stall

Vibration regimes recorded for fans and HPC of both engines, reported in the previous plot, do not indicate abnormal vibrations in the seconds before the application of the TO / GA command, vibrations possibly due to impacts with birds. The evolution of the fan and HPC vibrations in the phases of approach and short final of the previously performed flights indicates a level of engine vibration similar to that observed in the flight of the accident.

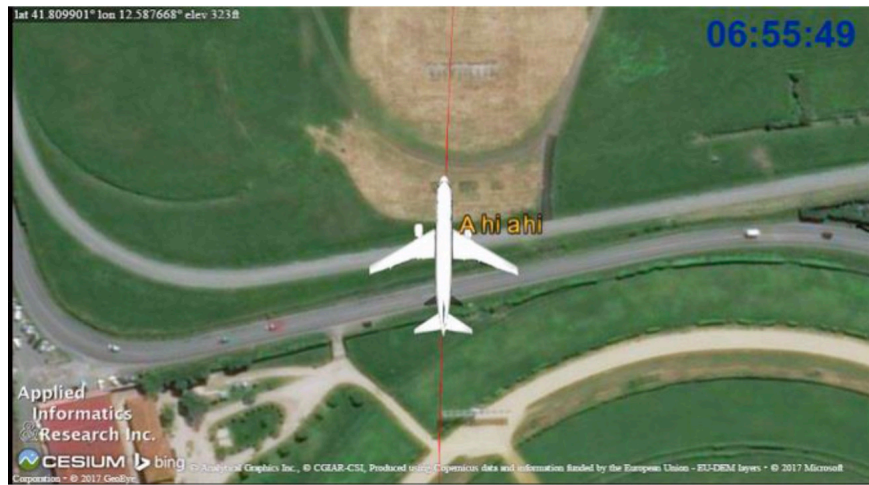
Picture 36 : bird sighting point along aircraft trajectory.

In particular, thanks to the synchronization of the CVR recording with FDR data, it is possible to locate the point where the commander repeatedly exclaims «Ahi!» (a period corresponding to the time 06.55'49 ", substantially overhead the Airport fence).

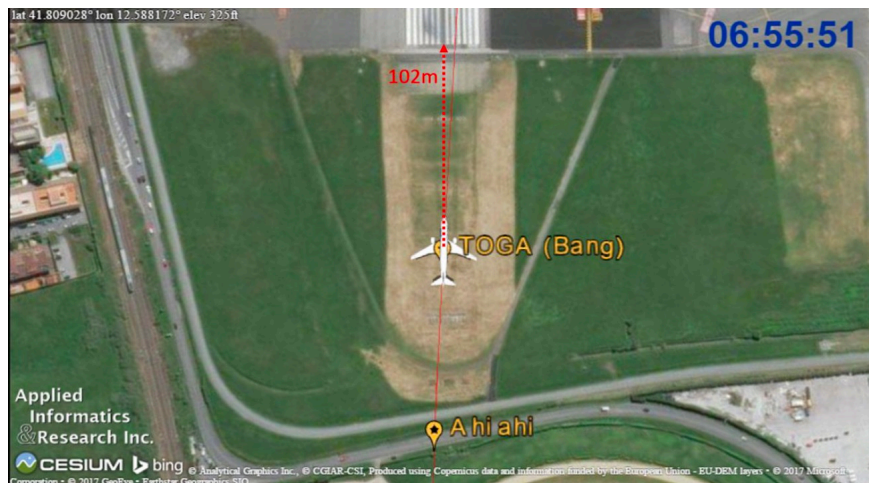
Picture 37 : engine stall and impact with birds

It was also possible to define the point where the application of the TO / GA occurred and the simultaneous "bang", corresponding to the stall of both engines and the impact with the starlings (a point corresponding to time 06.55'51 ", about 100 m from the beginning of the runway).

This last point is substantially on the vertical of the maximum concentration area of bird carcasses found on the ground.

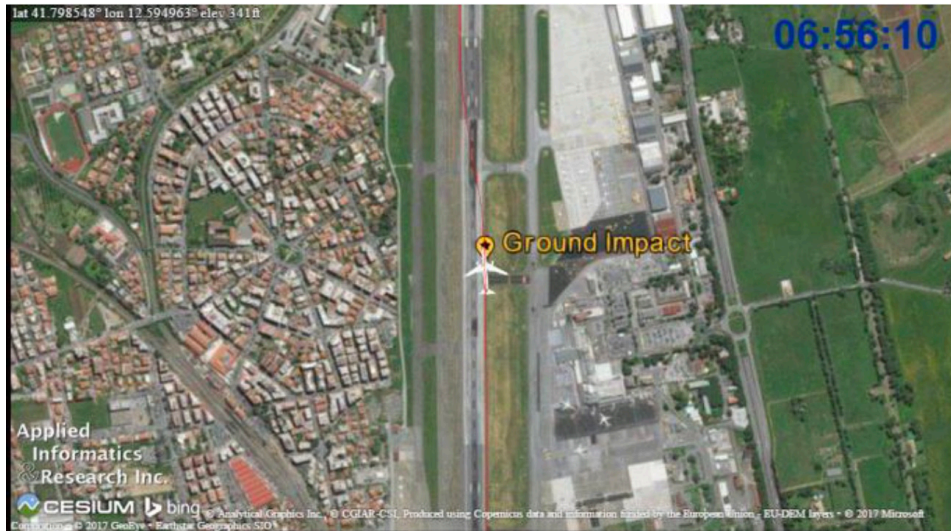
Picture 39 : point of impact with the ground

At 06.56'10 ", the aircraft touched the ground (switching of the WOW) with a pitch of 10° and roll -6°, indicated a speed of 120.75 knots, a variometric speed of -1064 feet, vertical acceleration of 2.66 g lateral -0.45 g.

So the aircraft lost altitude due to the aerodynamic stall, with the throttle levers of the engines in the position of maximum power request, without however any consequent response from the engines, and impacted the ground near the taxiway "AC", at about half the total length of the runway, with a vertical acceleration of 2.66 g.

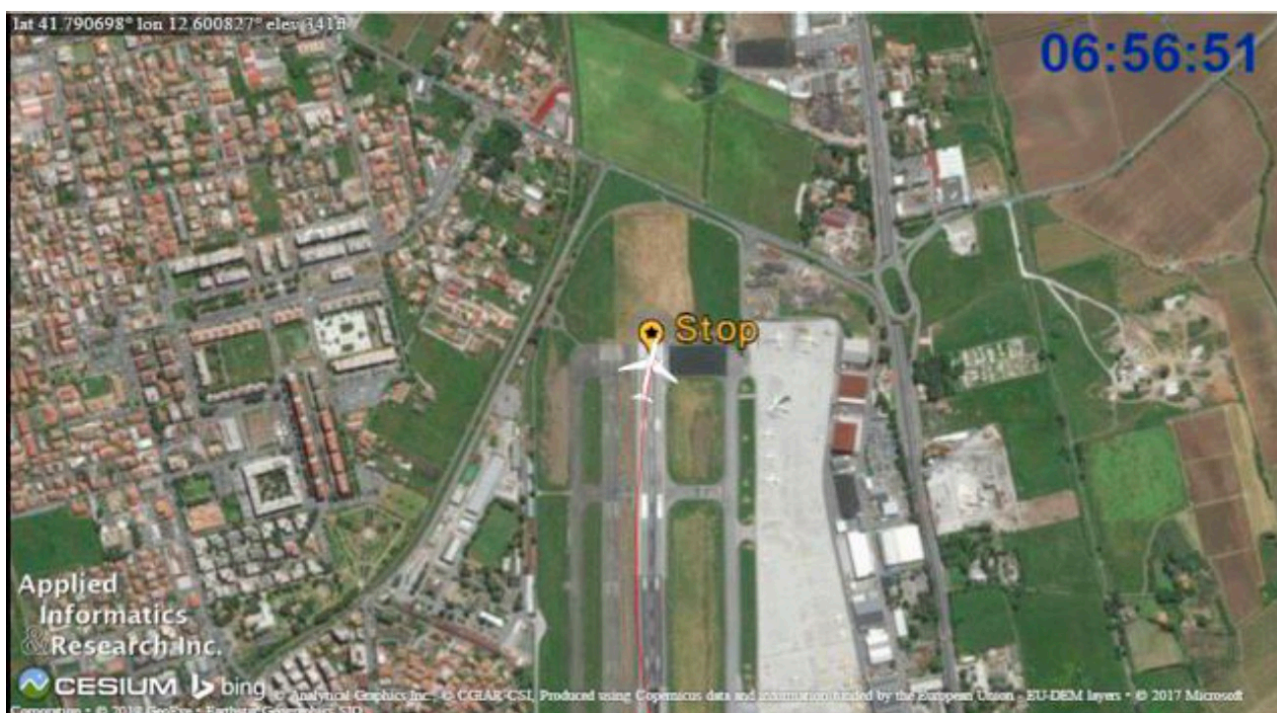
Picture 40 : stopping point on the runway

After 9 seconds (06.56'19 ") from the contact with the runway, the unsafe gear indication was activated for the left one, indicated by the "L GEAR WARNING" signal switching.

The aircraft stopped on the runway at 06.56'38", about 50 m from the end of the runway.
