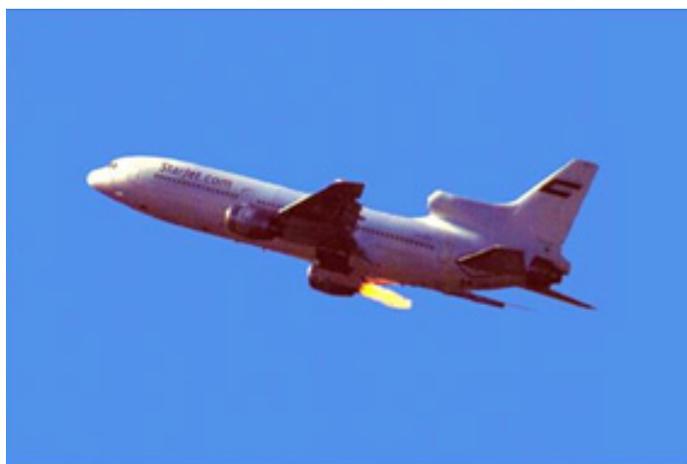
(Source Le Parisien)

The incident, an engine surge after takeoff, stirred great emotions, which were heightened by the publication of a photo of the airplane in flight, with a large flame trailing behind one engine. Questions asked by the passengers and by those from the airport's neighbouring area were widely spread via the media.
