COMANDO DA AERONÁUTICA
CENTRO DE INVESTIGAÇÃO E PREVENÇÃO DE
ACIDENTES AERONÁUTICOS

FINAL REPORT
IG - 057/CENIPA/2015

SERIOUS INCIDENT

A320-214

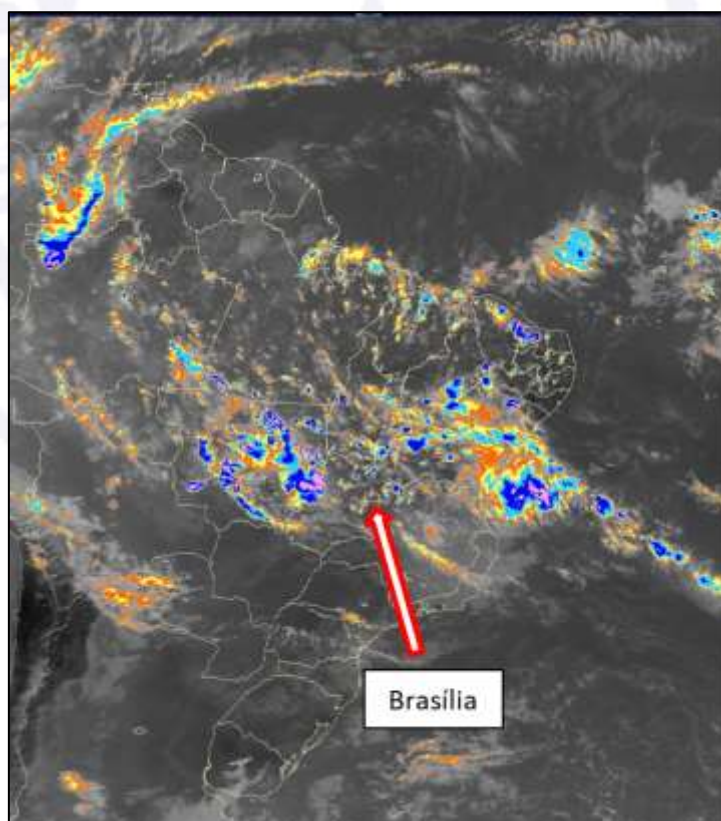
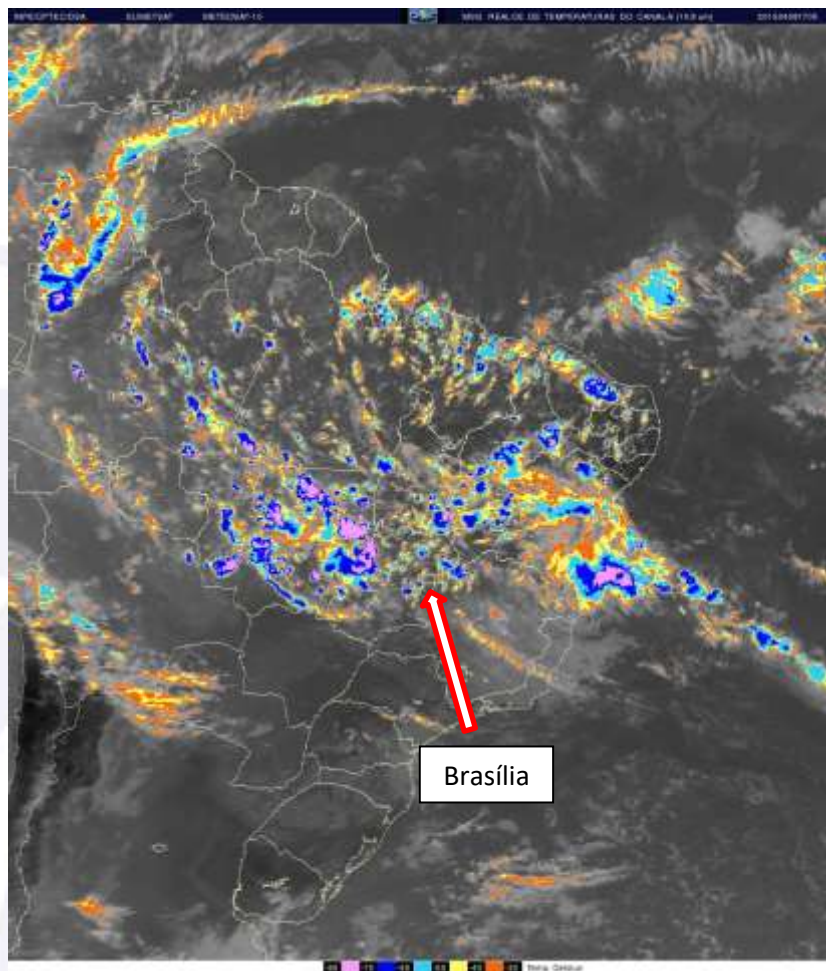
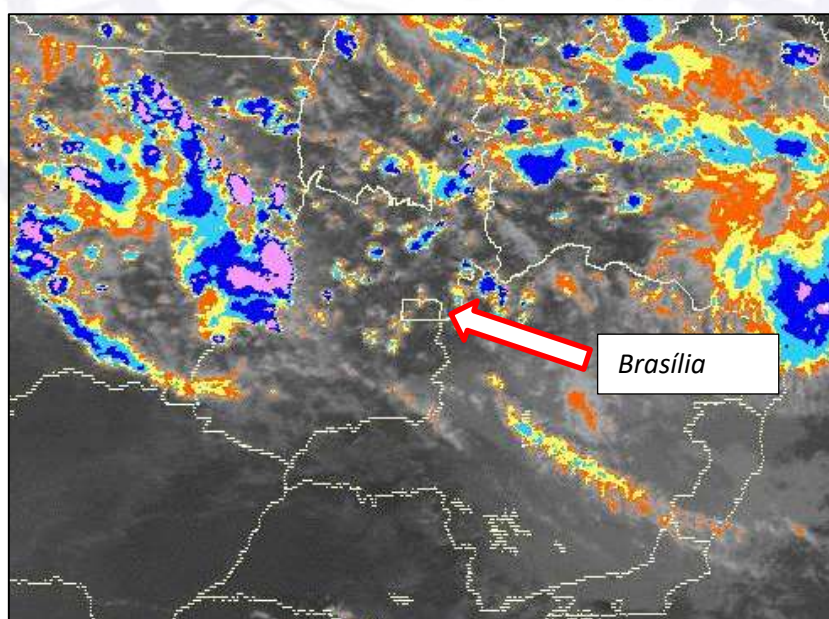
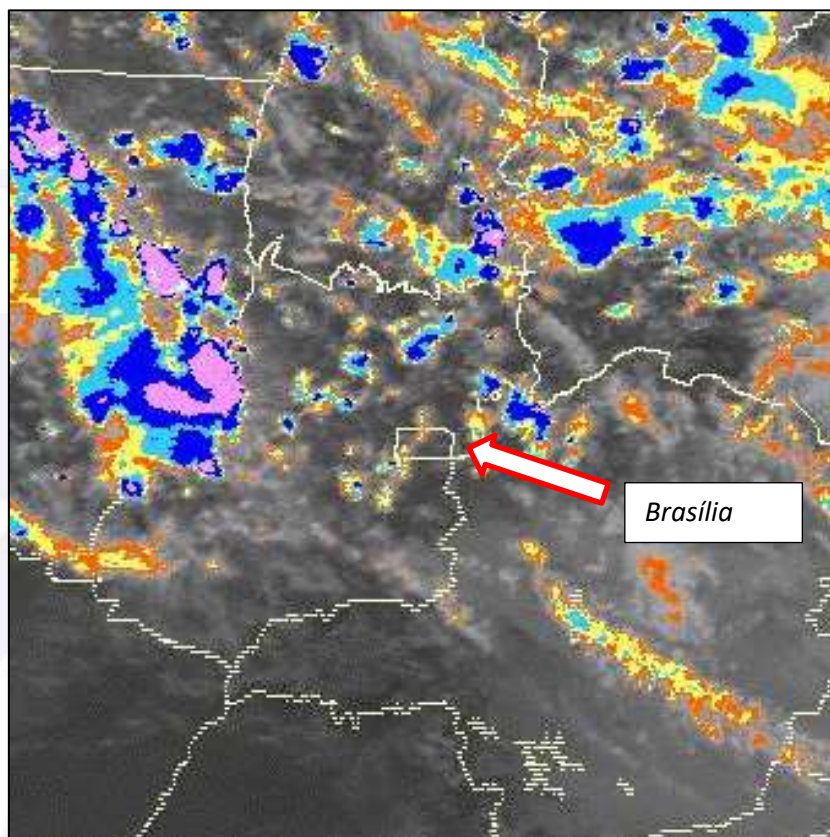
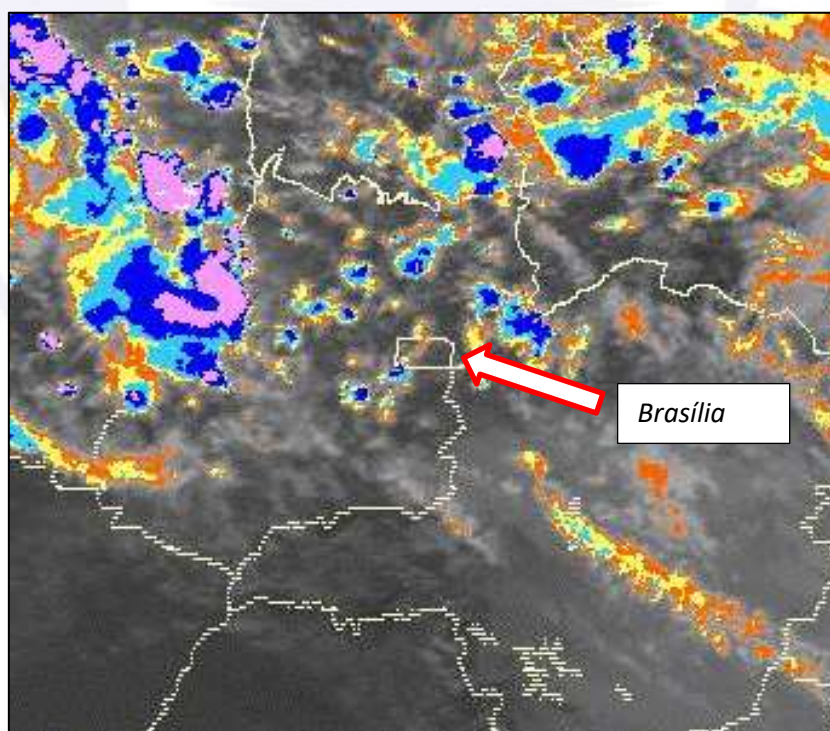
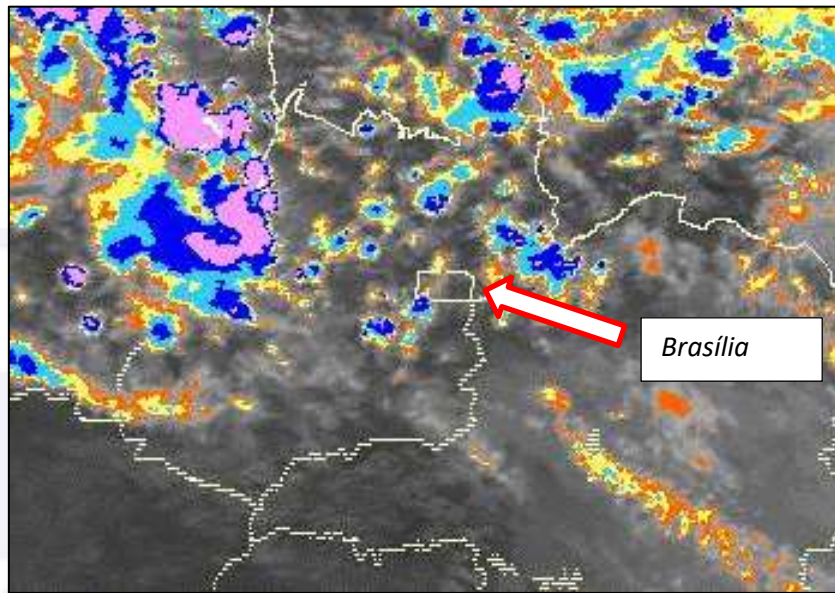
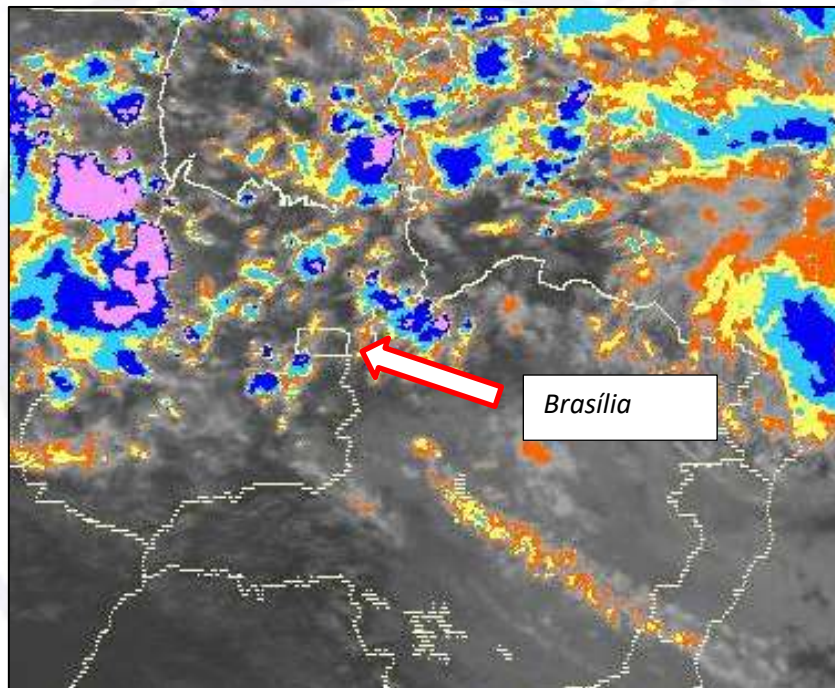
Brazil's satellite images on 08APR2015, between 1600 and 1700 UTC, depicted large area of instability, with isolated CBs over North and Center-West regions, associated to a cold front on the coast of the Northeast region (figures 4, 5, 6, 7, 8, 9 and 10). It is possible to see CB areas over *Brasília*, where SBBR is located.

SBBR area was surrounded by unstable atmospheric conditions, as verified on meteorological messages and on satellite images.

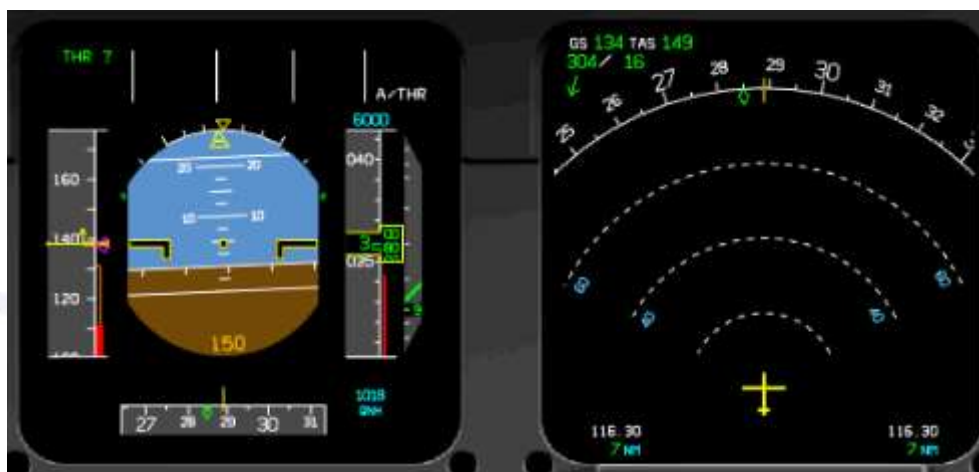
The final phase of the approach (since 150 ft AGL) and go-around procedure (until 130 ft AGL) lasted about 20 seconds. According to FDM data, during this part of the flight, the wind direction varied about 197° , and its intensity varied from 16 kt headwind to 13 kt tailwind.

It was also possible to observe GS Mini variations shortly before the landing (Figures 17 to 21).

Figure 17 - FDM data on PFD and ND.

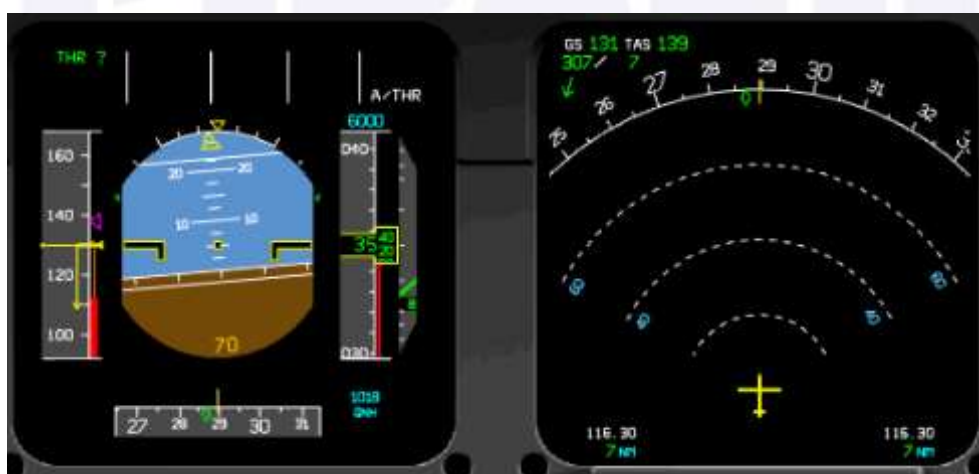
Figure 18 - FDM data on PFD and ND showing the beginning of the go-around procedure, the moment the levers were pushed forward, passing through the FLX-MCT thrust position, hitting TOGA thrust position, 1 second later.

Which procedure is referred to? Was the crew supposed to apply TOGA thrust? Referring to page 23, figure 18, it appears that they applied MCT/flex instead.

The FDM data showed that the crew applied TOGA thrust during the reject landing procedure. The Figure 18 was used to show the wind direction in the beginning of the missed approach procedure, when the thrust levers passed through the MCT/Flex thrust position toward the TOGA thrust position, to compare with the wind direction in others phases of the reject landing. This was used to show the windshear possibility.

From figure 18 page 23, it appears that the crew did not apply the correct procedure to perform a go around. Airbus nor BEA were given access to FDM data so it is difficult to assess its impact.

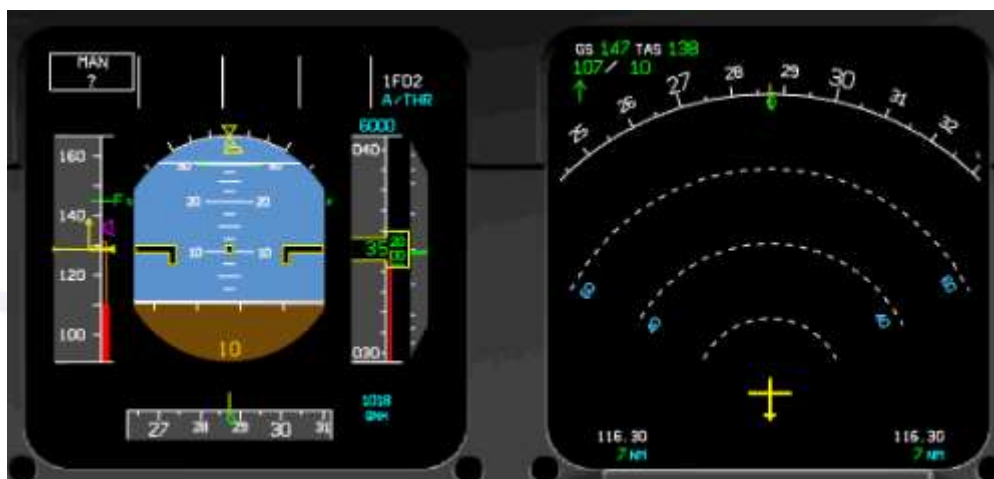
Figure 20 - FDM data on PFD and ND shortly after the aircraft becomes airborne, during the go-around procedure.

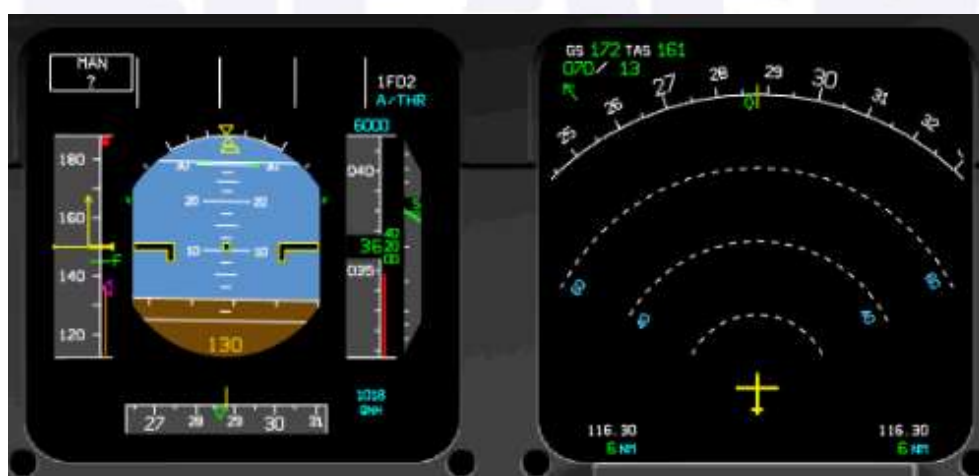
Figure 21 - FDM data during the go-around procedure.
