Incident

AAIS Case N° AIFN/0011/2018

Inadvertent Opening of Emergency Exit Hatch and Deployment of Slide Ramp

Operator:	Saudia Airlines
Make and Model:	Airbus A320
Nationality and Registration:	Saudi Arabia, HZ-AS55
Place of Occurrence:	Dubai International Airport
State of Occurrence:	The United Arab Emirates
Date of Occurrence:	20 September 2018

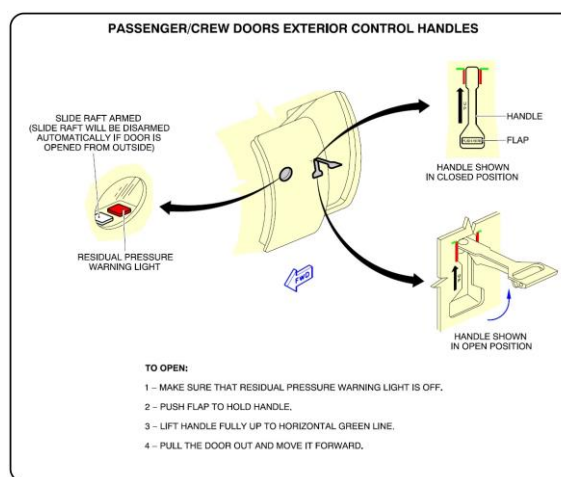
Figure 3. Passenger door opening mechanism
[Source: Airbus]

The four type I passenger doors may be operated from outside the aircraft by lifting a control handle upright, after the cabin pressure has been equalized by the flight crew, and the doors have been disarmed by the cabin crew from within the cabin. Refer to figure 3.

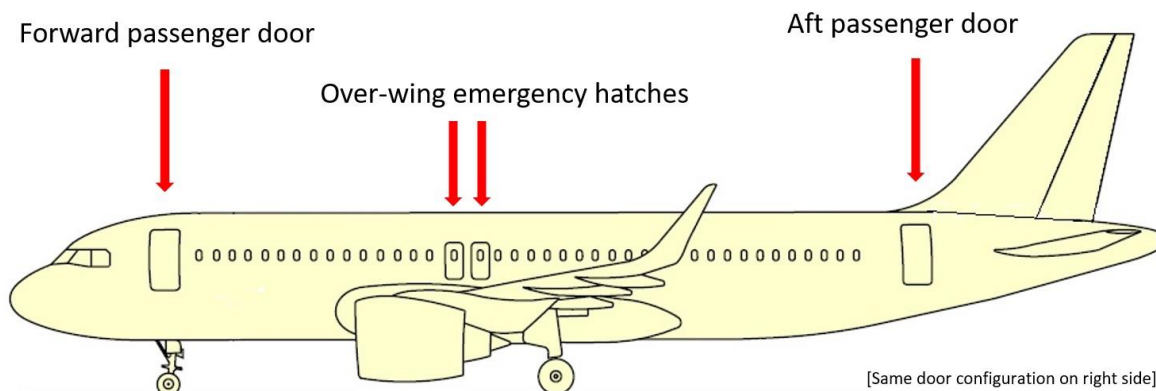
Figure 5. A320 (Emergency exit) door configuration

It is equipped with four floor level type I emergency exits (doors 1L, 1R and 4L and 4R), and four type III emergency exits at rows 35 and 36 (forward over-wing exits L and R, and aft over-wing exits L and R) as shown in figure 5. Opening either of the floor level type I exit doors in the armed position, automatically deploys a slide raft to assist evacuees exiting from these doors. The opening of any of the over-wing emergency exit hatches, deploys a slide ramp over the trailing edge of the wing to assist in evacuation.
