Havarikommisjonen
Accident Investigation Board Denmark

FINAL REPORT

ATR72 200

OY-LHA

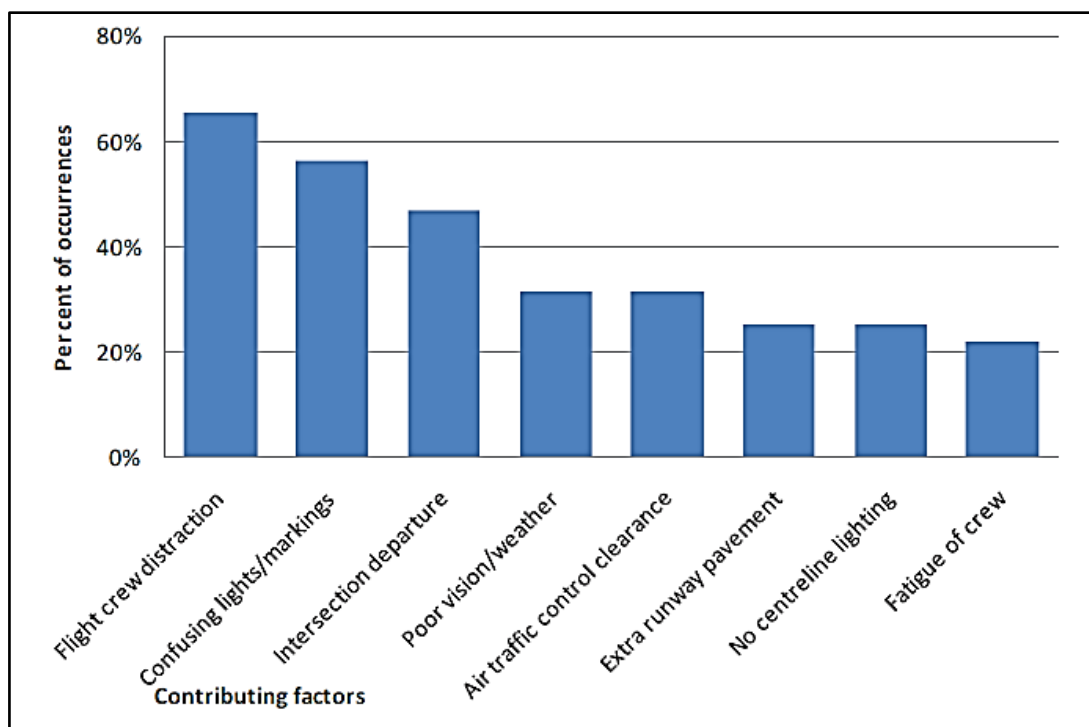
Factors contributing to misaligned take-off occurrences.

- *Night-time operations*
- *The runway and taxiway environment, including confusing runway entry markings or lighting, areas of additional pavement on the runway, the absence of runway centerline lighting, and flush-mounted runway edge lighting*
- *Flight crew distraction or inattention*
- *Bad weather or reduced visibility*
- *Displaced threshold or intersection departure*
- *The provision of an air traffic control clearance when aircraft are entering the runway or still taxiing*
- *Flight crew fatigue.*
