**The Aircraft Accident Investigation Board of the
Islamic Republic of Iran**

Flight PS752 Accident Investigation

Final Report

AAIB File Number:	A981018URPSR
Type of Occurrence:	Accident
Date of Occurrence:	Jan. 08, 2020
Place of Occurrence:	Near IKA Airport (OIIE) - I.R of Iran
Aircraft Type:	B737-800
Registration:	UR-PSR
Date of Issue:	Mar. 15, 2021

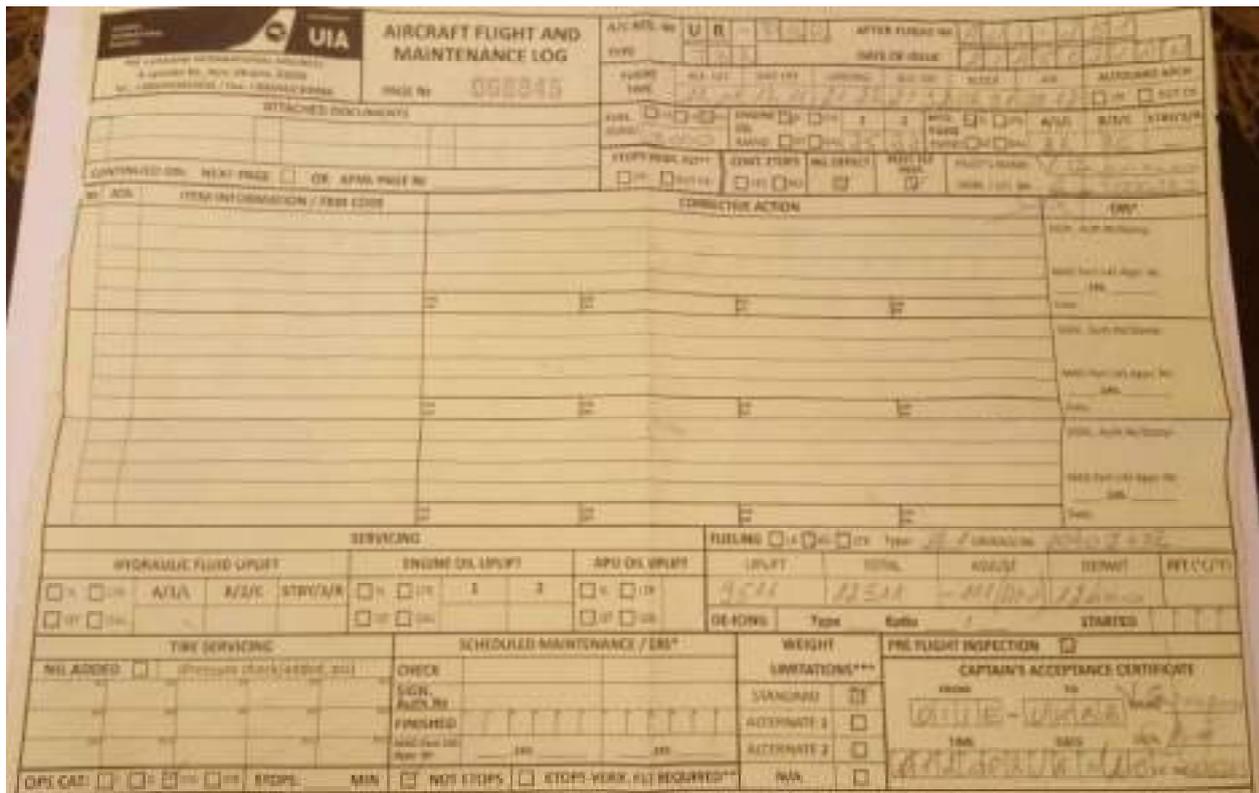
According to the Aircraft Flight and Maintenance Log page No.068845, Figure 4, on the flight before the accident, the aircraft departed at 21:41 from Kyiv, Ukraine to IKA, and after flight landing and preparations, no technical defect was reported by the pilot requiring a technical action.

Figure 4- Aircraft flight and maintenance log

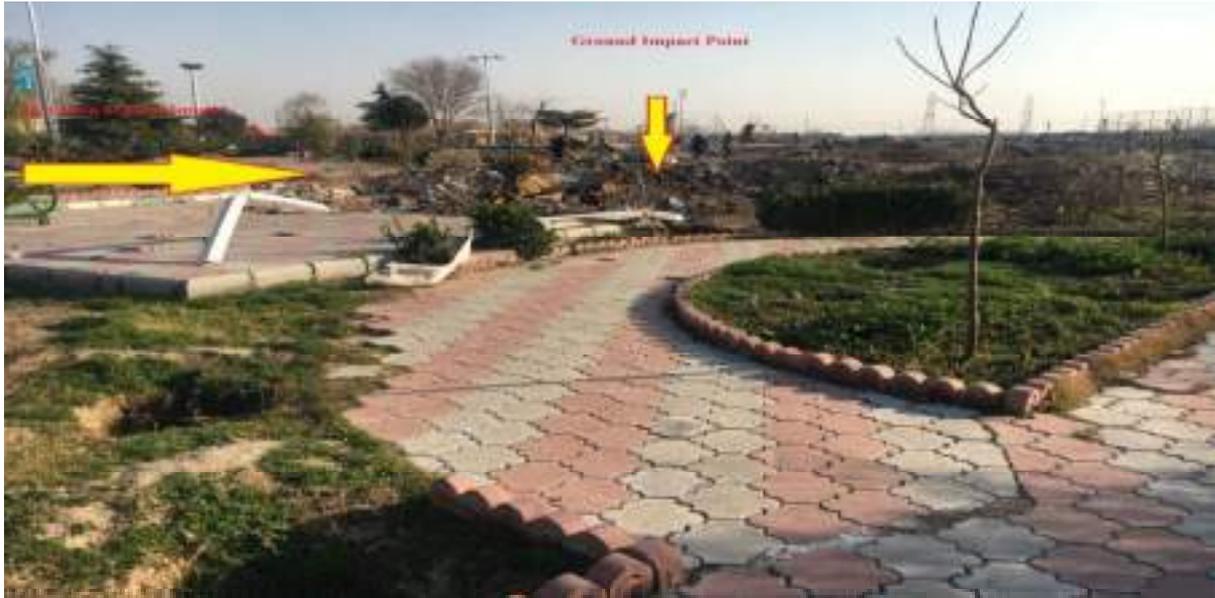
Figure 7- The first ground impact of the aircraft

Shortly after the transponder stopped transmitting signals, the aircraft heading was changed to the right and after turning, headed toward the airport. The aircraft lost its altitude gradually and after passing by Khalaj Abad residential area impacted a gazebo roof in a recreation park with the position $35^{\circ}33'45.4''\text{N}51^{\circ}06'11.3''\text{E}$ and then hit the ground (Figure 7).

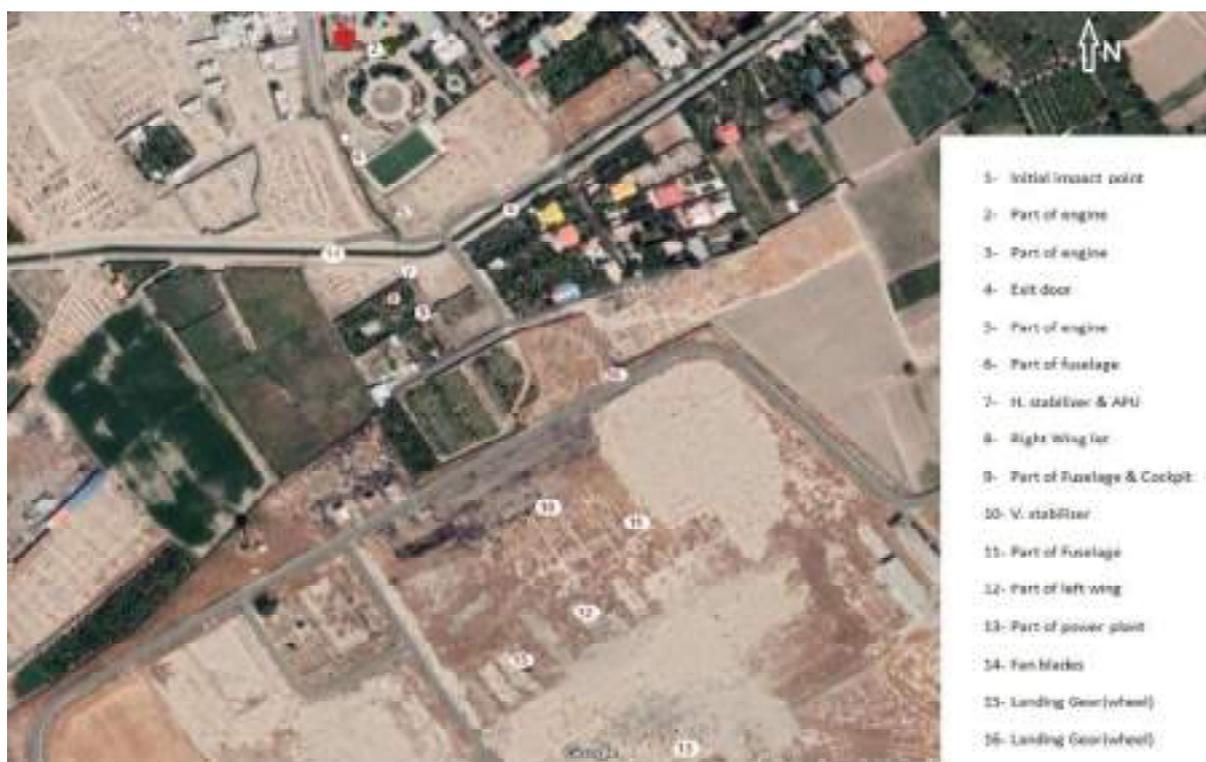
Figure 8- An overview of the aircraft parts distribution

The impact with the ground created a large hole in the park, then the fuselage distanced from the ground and went on to a soccer pitch, hit its fences, passed by a water canal, again hit walls of private gardens and disintegrated completely as shown in Figure 8. The evidence and pieces gathered from the aircraft at the main accident site showed that the aircraft still maintained its relative integrity before impacting the ground. Interviews with eyewitnesses along the flight path confirmed this as well.

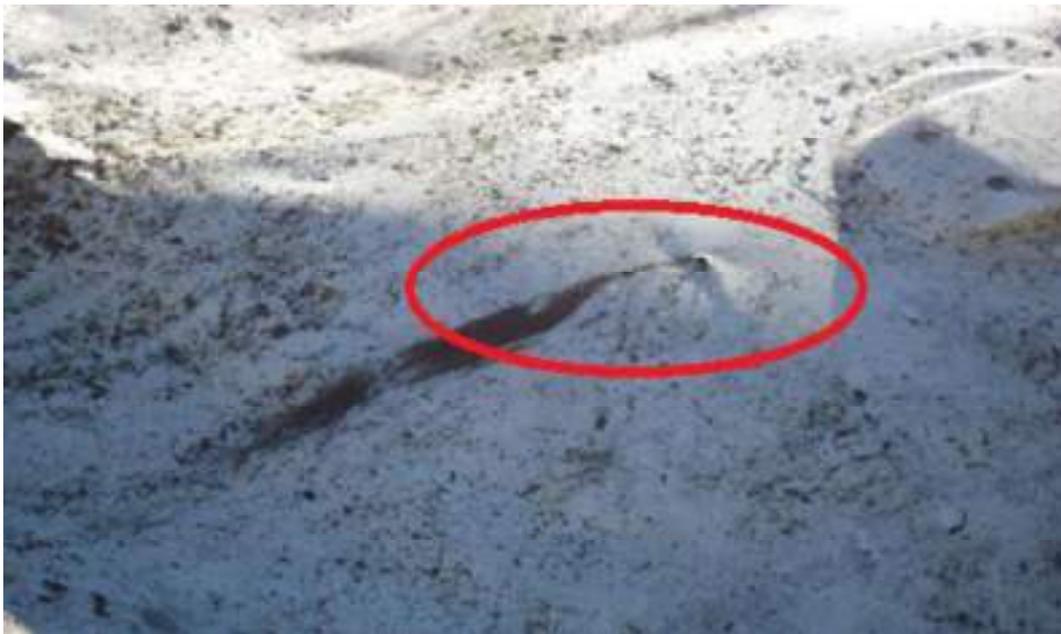
A large number of ruptured holes were seen on the aircraft fuselage, which varied in terms of size, shape and direction in opening, though they were of two different types. One, which was fewer, shows the thick smoke towards outside of the fuselage (Figure 16, Figure 17, Figure 18 and Figure 19), and in the other, with a higher number, only ruptured holes could be observed (Figure 20 & Figure 21).

Figure 17- Hole on the fuselage near the cabin with a trace of different color of smoke

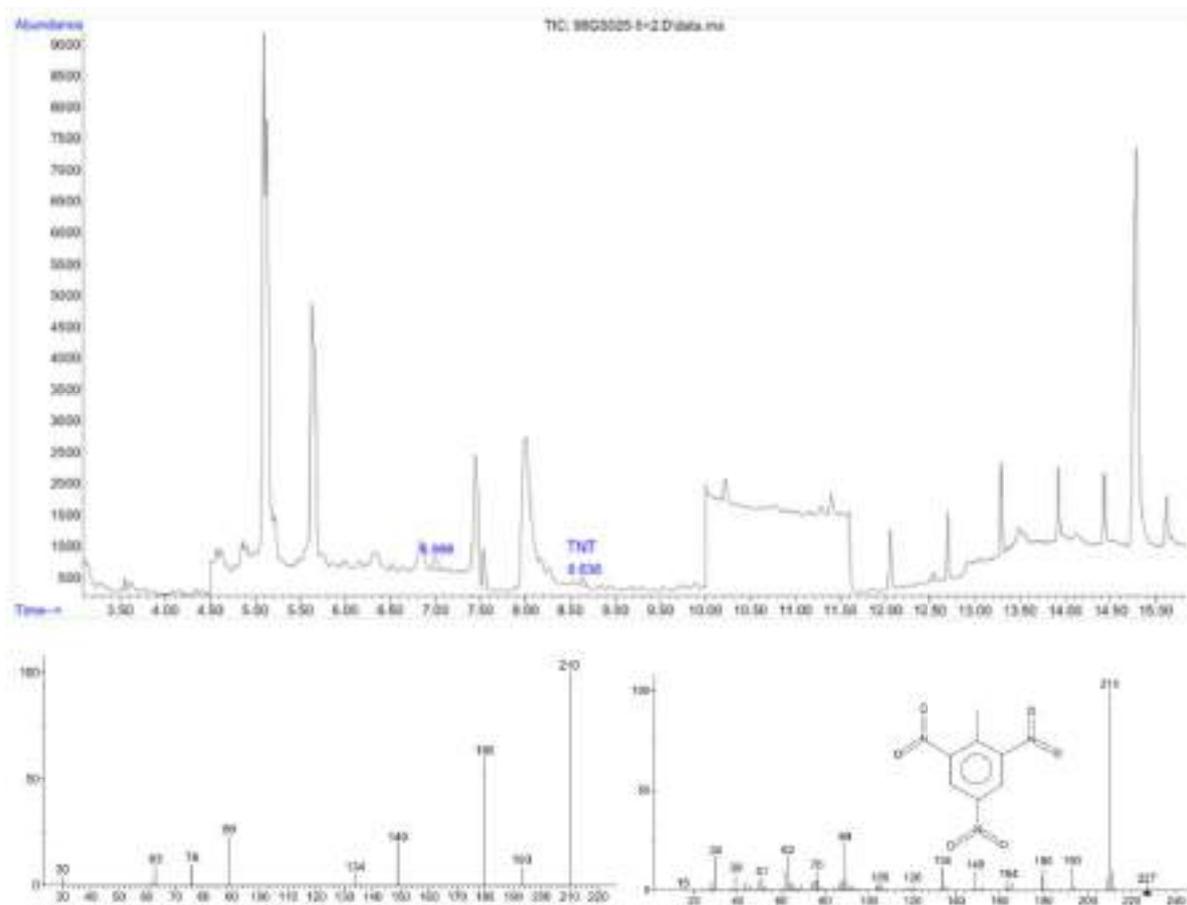
Based on the results yielded through GC/Mass chemical analysis, the existence of Trinitrotoluene (TNT) explosives with a chemical formula C₇H₅N₃O₆ was confirmed in the aircraft wing skin, which was found before the crash site. (Figure 27)

Figure 28- Gas chromatography–mass spectrometry; GC-MS, of aircraft wing skin piece

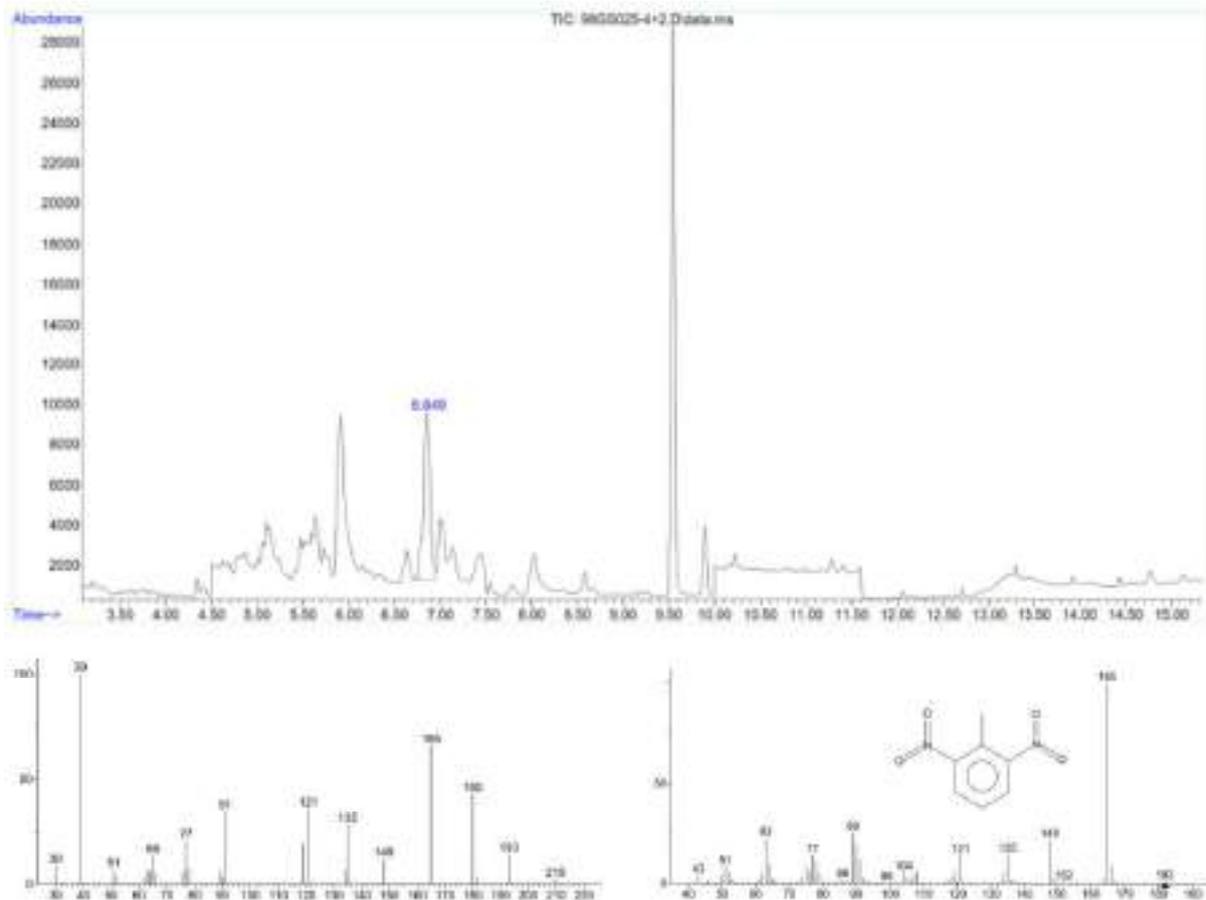
By sampling the air conditioning system and the two ELT pieces of the aircraft (Figure 29) and performing gas-chromatographic-mass spectrometry on each of the parts, the presence of negligible amounts of Dinitrotoluene (DNT) with the chemical formula $C_7H_6N_2O_4$ was proven.

Figure 30- The GC-MS of the ELT and heat exchanger

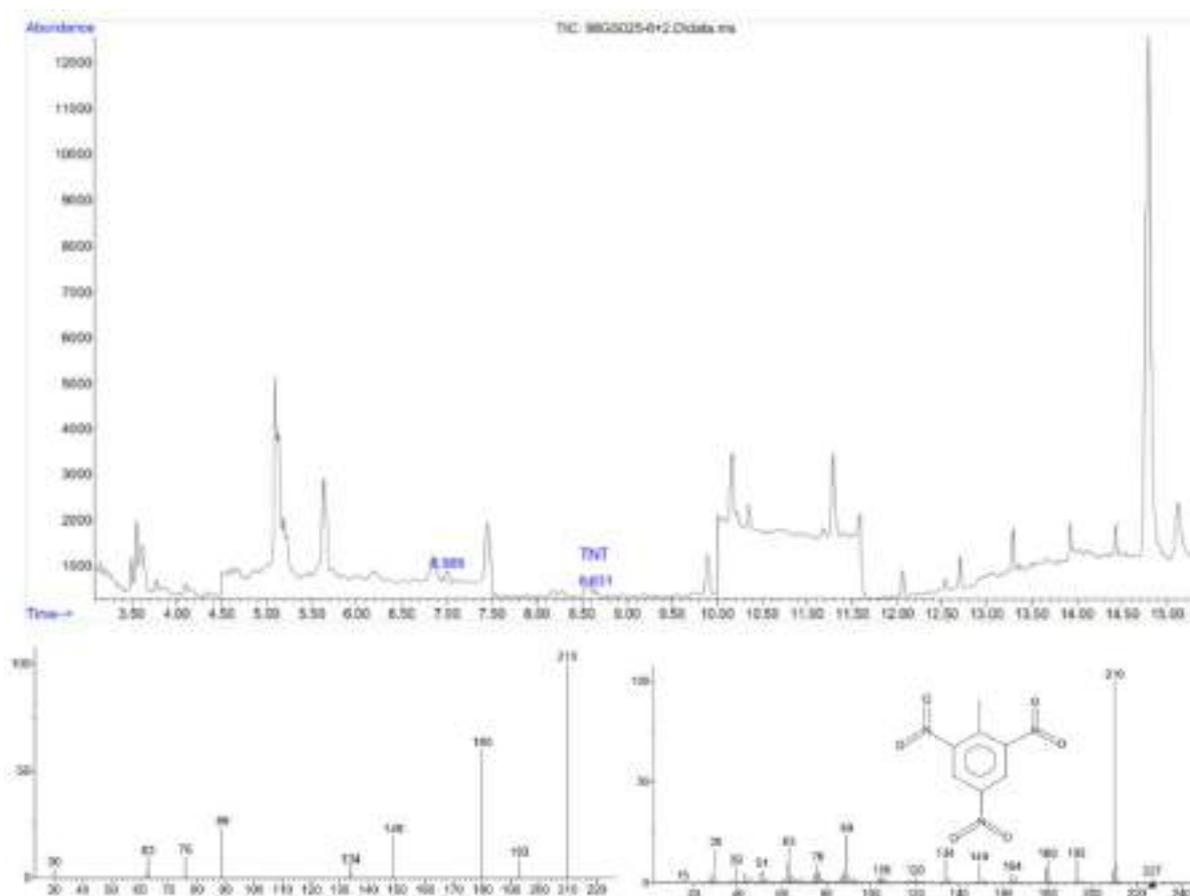
According to the spectrometry obtained from the interior part of the aircraft cabin window (as shown in Figure 31), the presence of explosive Trinitrotoluene (TNT) was detected (Figure 32).

Figure 32- The GC/Mass test result from the interior of part of the aircraft cabin window Pieces

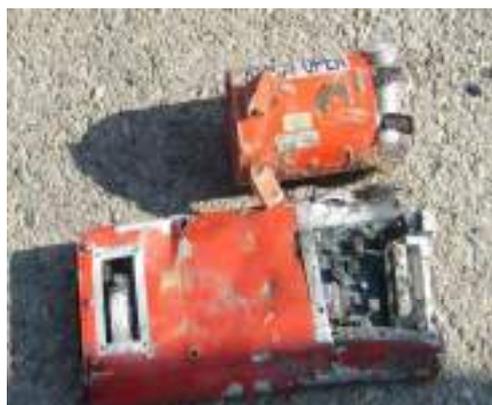
Damage to CVR had been more serious, whose main memory (CSMU) was detached due to the impact severity. The condition of these recorders indicated that the CVR and FDR had not been exposed to the fire in the aircraft, and after the ground impact, they were damaged or exposed to fire. (Figure 35 and Figure 36)

Figure 36- CVR physical appearance after the crash

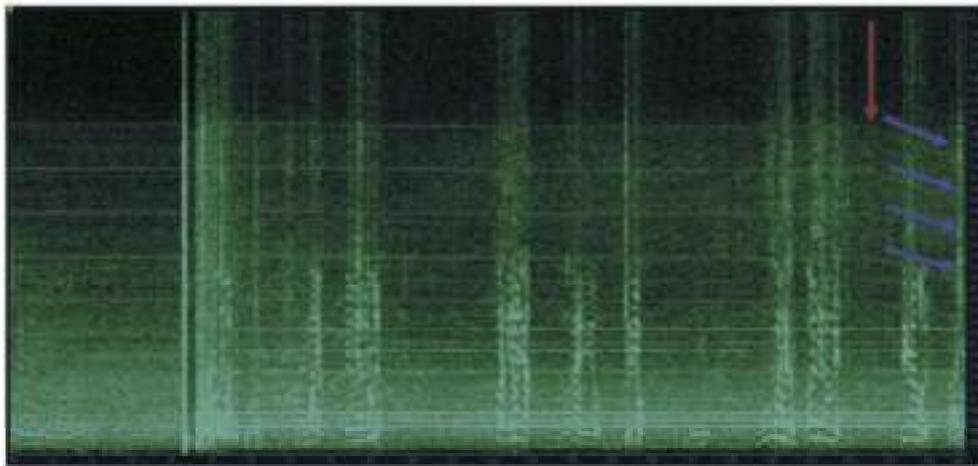
A drop of frequencies began 2.445s before the end of CVR recording.

Figure 40- Drop of frequencies recorded in CVR. Photo:BEA

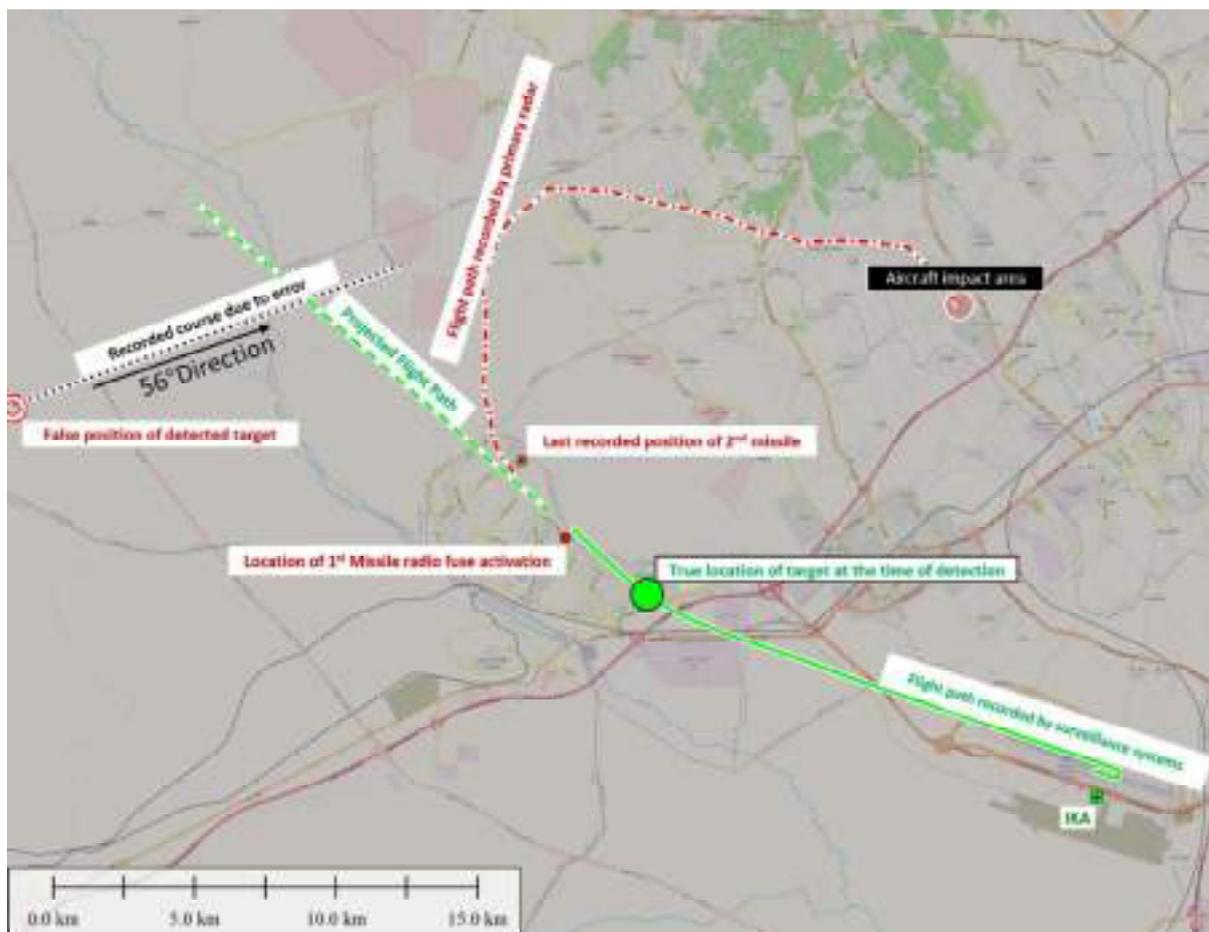
At 06:15:22, the last communication between the second missile and the defense system was recorded in a place close to the aircraft route. After that, the defense system showed a message indicating the strike had failed, with the aircraft clearing from the radar lock-on after some time.

Figure 41 depicts the trajectory and true location of the aircraft, wrong detected position and locations related to the activation of the missiles.

Figure 41- The location of key events in missile launch

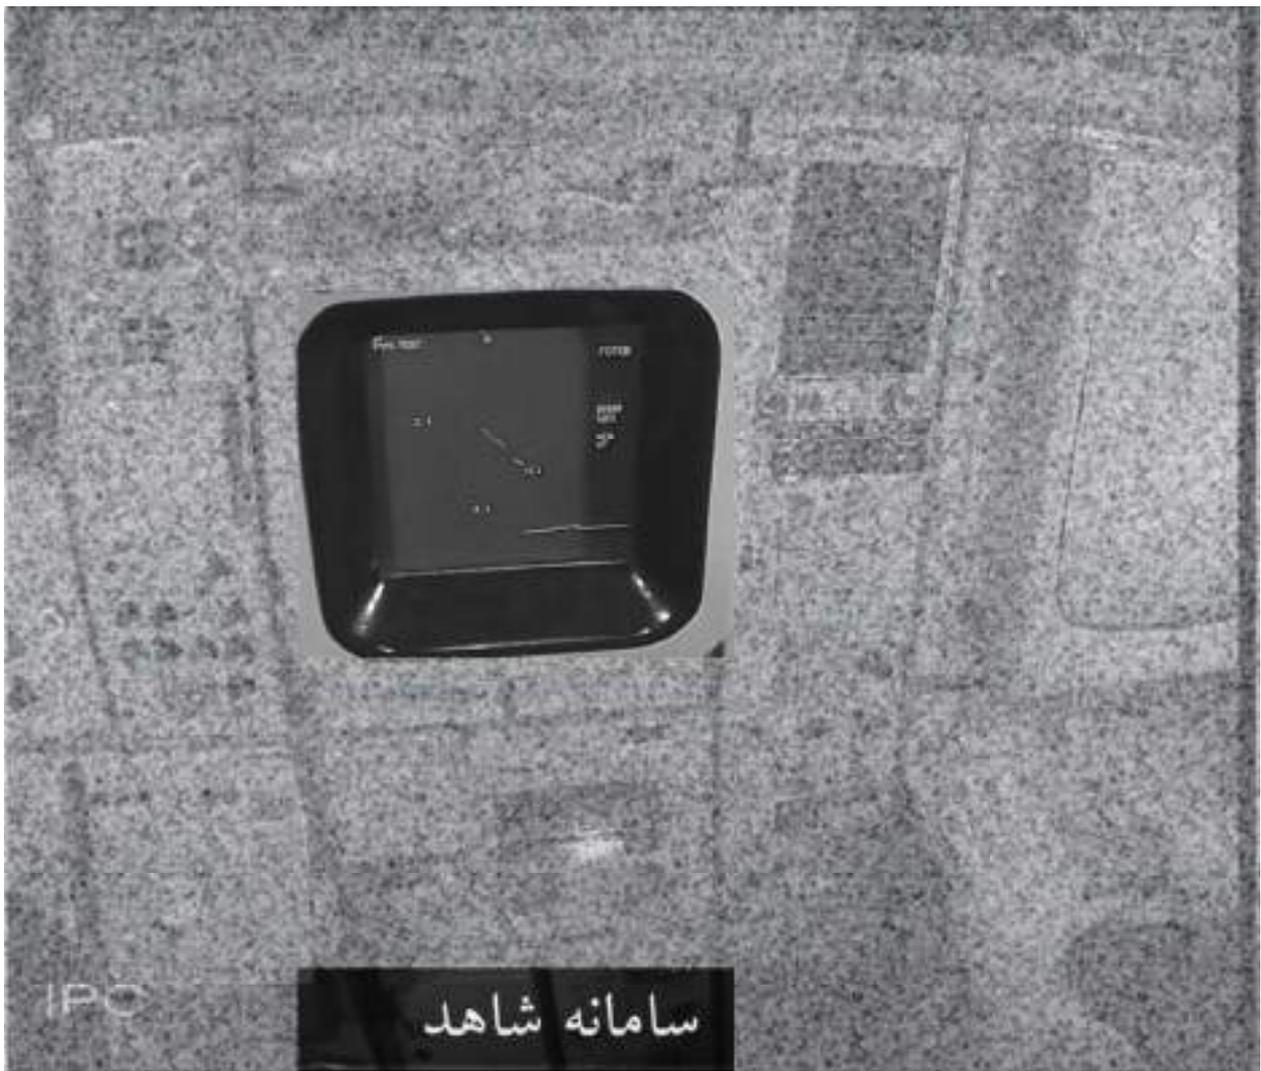
Figure 54- The target direction in the reference ADU in the simulation with correct North alignment

The simulation also indicated that the aircraft flight operation did not play a role in the occurrence of the error made by the air defense unit operator. In the two times of simulation, the reference unit operators detected the aircraft from the IKA direction (Figure 54), while the main unit operators detected it approaching from the western area (Figure 55).

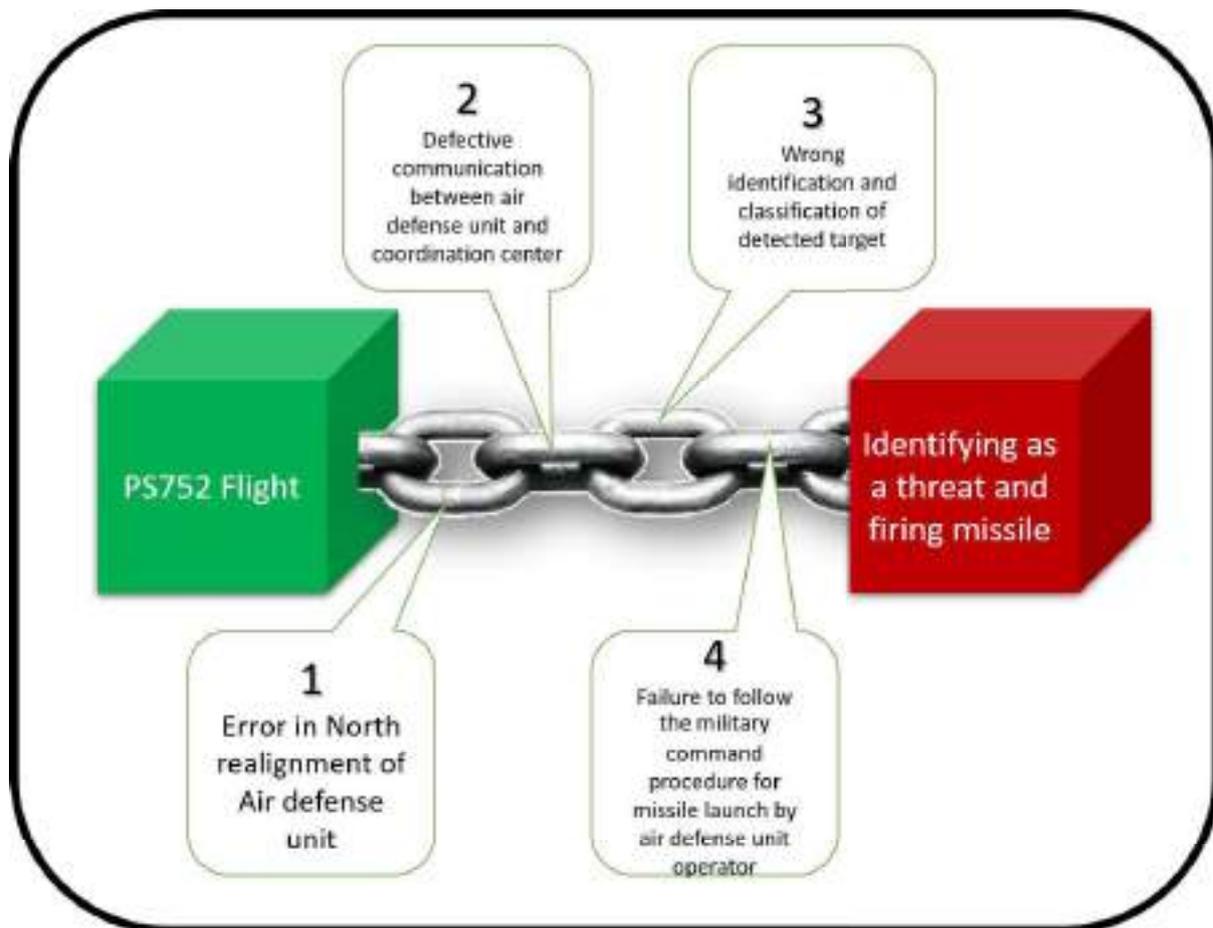
Figure 56- The chain of events leading to firing missile at PS752

The target specifications were announced to the command center, but the message was never relayed. Without receiving a go-ahead or response from the command center, he came to identify the target as a hostile one and fired missile at the aircraft against the procedure planned.

The chain of events observed by the investigation team leading to firing missile at PS752 is illustrated in Figure 56.

The existence of this threat and the possibility of such chains being formed had not been predicted, and had not been considered in the calculations of the risk associated with misidentification.

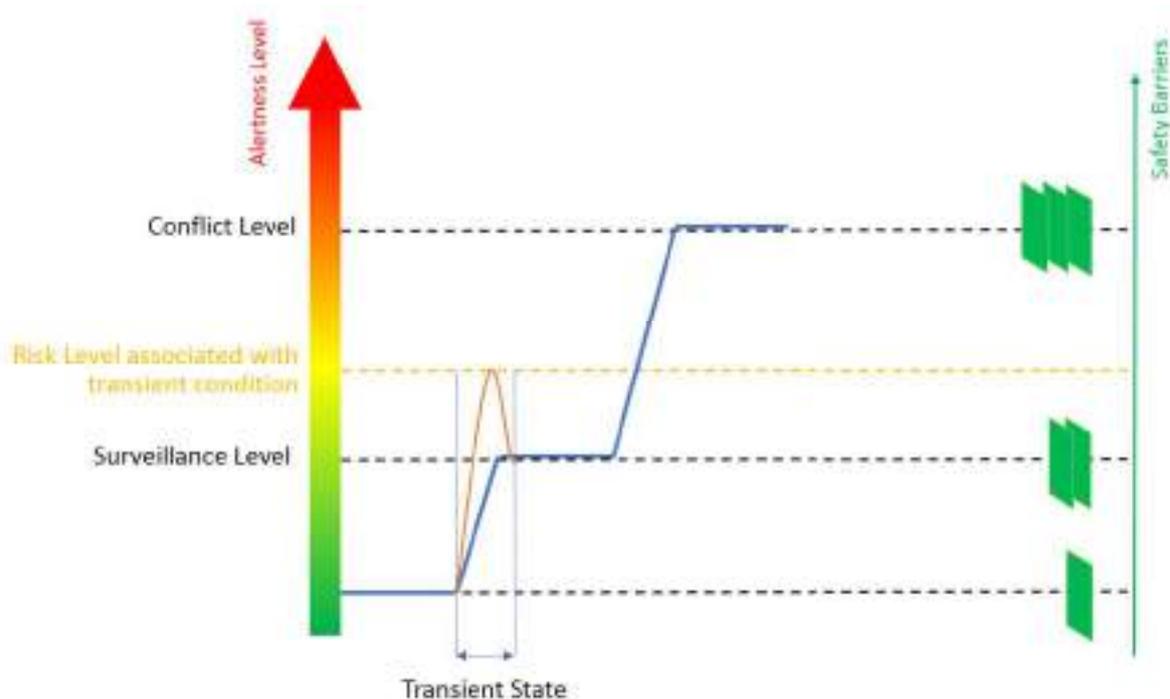
Figure 57- Alertness levels and risk in transient condition

In PS752 accident case, taking into account that the prevailing conditions rapidly changed at about 02:00, it is likely that at the time of the accident, the transition time was not finished yet and this transient condition contributed to human errors and the existing hazards within the whole system.

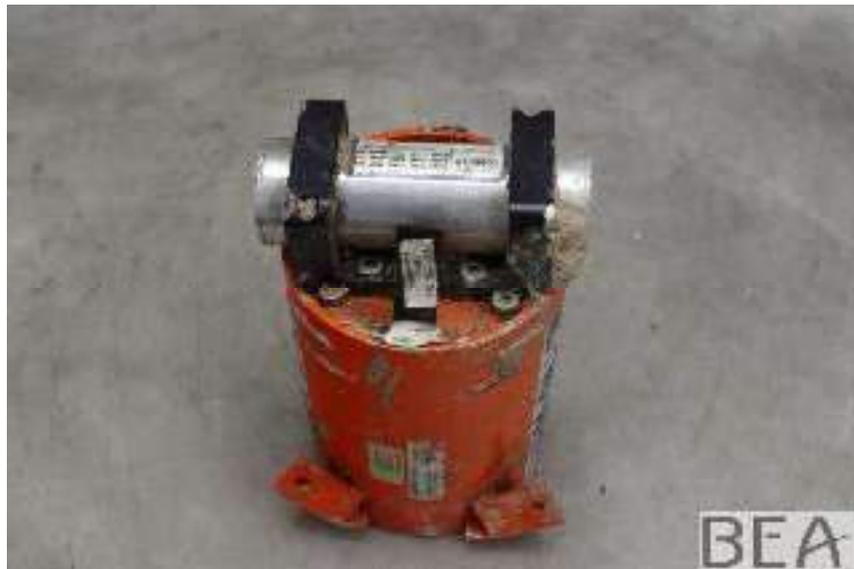
Figure 1: CSMU and flex cable

The CVR was visually inspected. The CSMU was not connected to the chassis. The CSMU showed some traces of impact but no evidence of fire. The ULB beacon was still attached to the CSMU. The flex cable was found torn off.

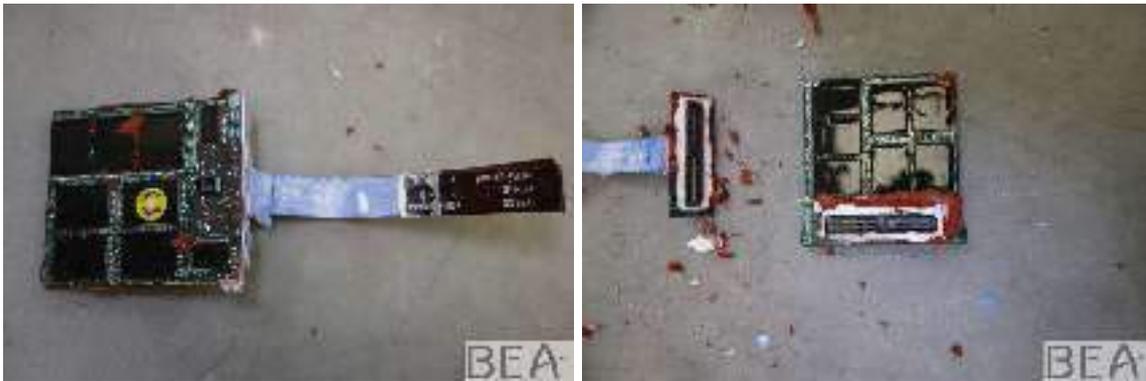
Figure 4: CVR memory board

The memory board is protected by a RTV silicon. This protection was removed to allow visual inspection of the board. The damaged flex cable was removed from the memory board.

The memory board was visually inspected under magnification. It was in good condition. The temperature indicator color showed that the memory board was not exposed to heat.

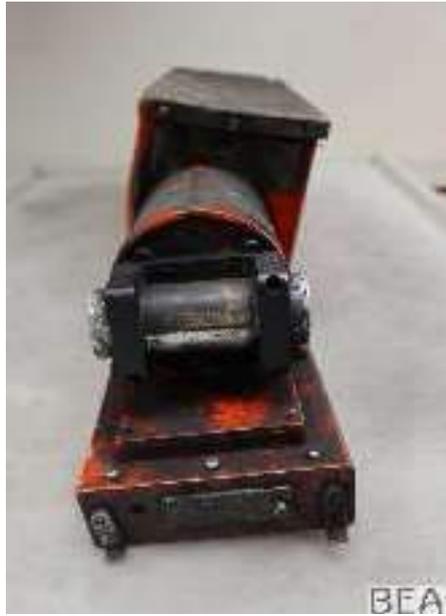
Figure 7: FDR chassis and CSMU

The FDR was visually inspected. The CSMU was still attached to the chassis. The flex cable was partially linked to the chassis. There were traces of fire and soot. The chassis was bent.

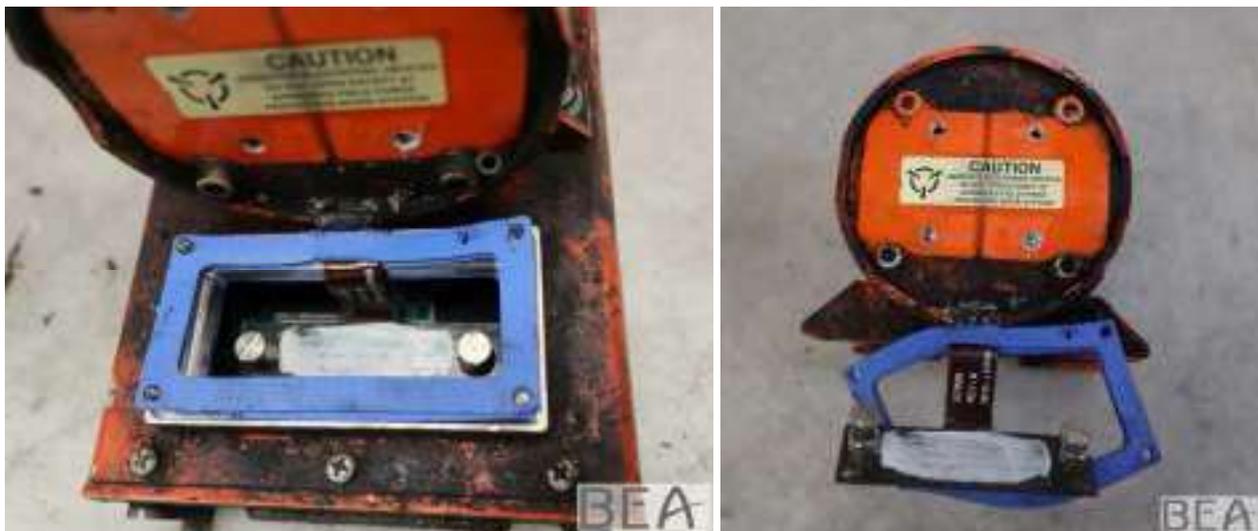
Figure 9: Separation of the FDR CSMU from the chassis

The screws of the flex cable cover were removed. The CSMU connector was disconnected from the chassis interface. The screws attaching the CSMU to the chassis were removed, two out of 4 were found loose. The CSMU was separated from the chassis.

The CSMU was opened by removing the screws and hold down latches to extract the memory board. One side of the flex cable was found torn off.

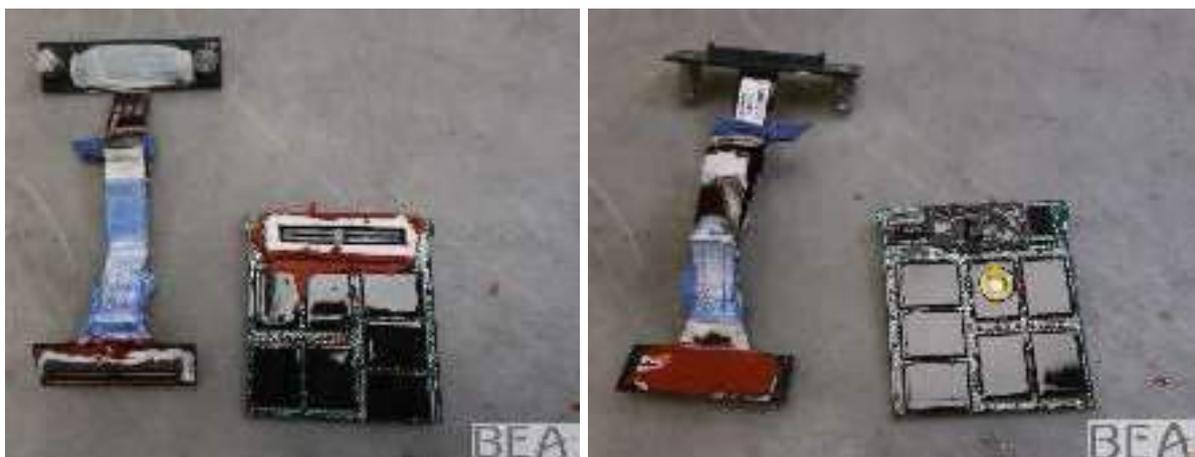
Figure 11: FDR memory board

The memory board is protected by a RTV silicon. This protection was removed to allow visual inspection of the board. The flex cable was removed from the memory board.

The memory board was visually inspected under magnification. It was in good condition. The temperature indicator color showed that the memory board was not exposed to heat.

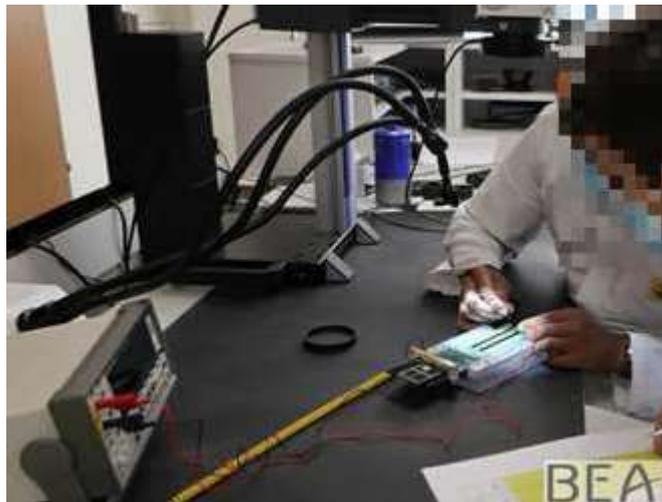
Figure 12: FDR electrical checks

The memory board was connected to the Honeywell HFR5 BEA adapter and electrical checks were performed. The values were consistent with the expected ones.

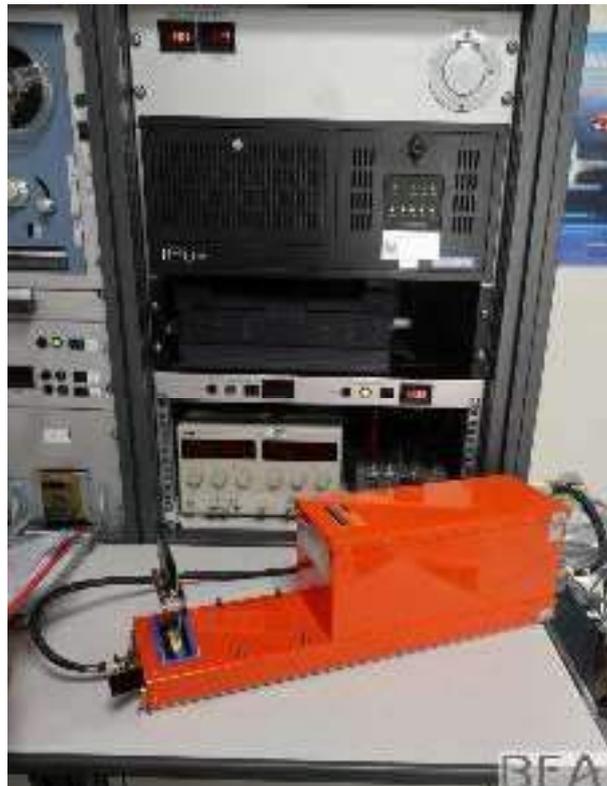
Figure 13: readout of the memory board on BEA HFR5-D chassis

The data was downloaded three times. The first download was done with the manufacturer software Playback-32 (with an issue), the second with the manufacturer software DLDR and the third one with Playback-32 (with no issue).

The raw files recovered with DLDR were reconstructed into one file with CHIPS software. The output file from Playback-32 was already a reconstructed raw file (DLU).

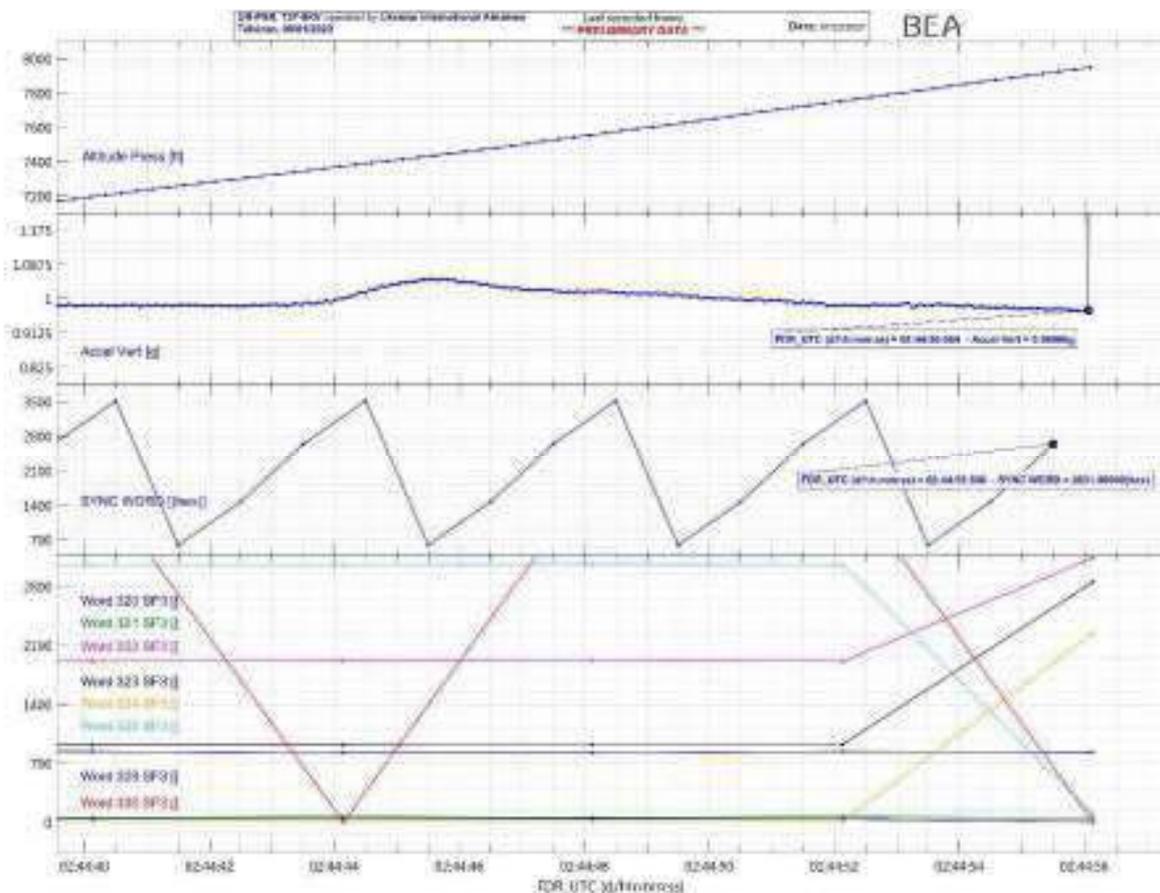
Figure 14: Plots of the last recorded words in the FDR file

All values recorded in the FDR raw file after word 321 of subframe 3, which is the last subframe (incomplete due to end of recording) recorded, are invalid and should not be considered.

In this document, the FDR analysis stops at the word 321, dated at 02:44:56.125 UTC.

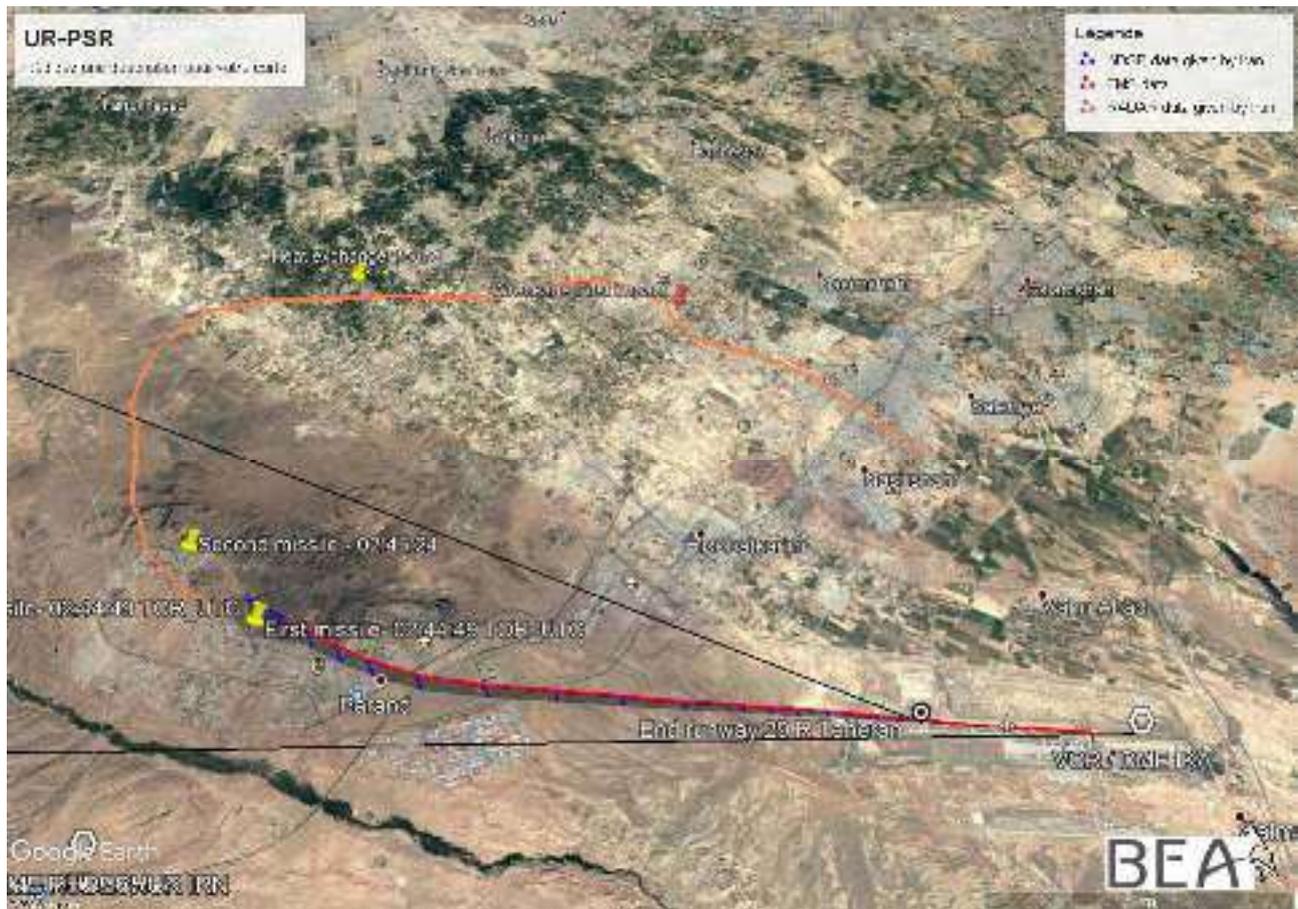
A Google Earth track file (in KML format) was produced using the FMS latitude and longitude recorded in the FDR (red curve), from take-off until the end of the FDR recording. The trajectory has been completed by Radar position (orange curve) and ADSB information (blue curve) provided by IIC.
