COMMAND OF AERONAUTICS
AERONAUTICAL ACCIDENT
INVESTIGATION AND PREVENTION CENTER

FINAL REPORT
A – Nº 67/CENIPA/2009

AIRCRAFT **PR - MBK**

MODEL **AIRBUS A-320**

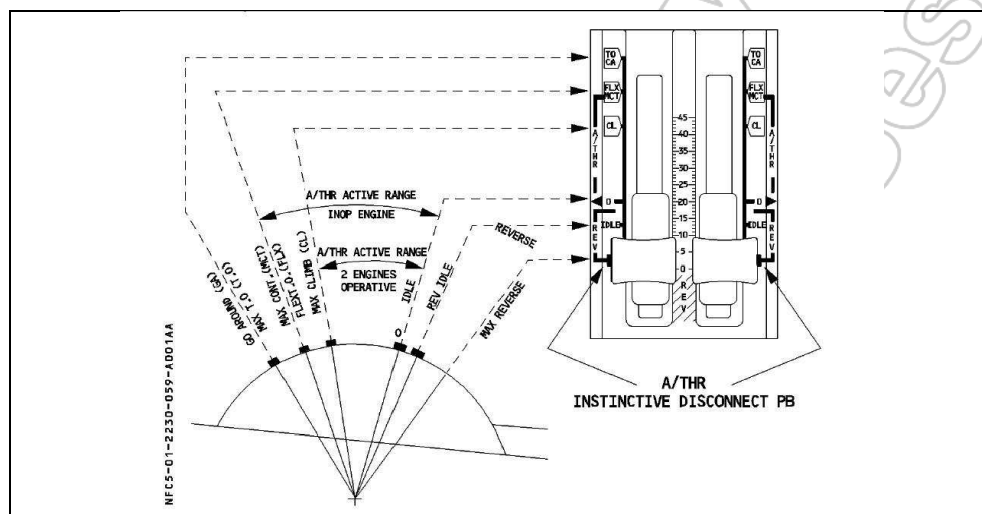
Figure 8 - Positions of the thrust levers.

The power control system of the Airbus A-320, shown in the figure 8, has 5 positions for the levers: "TOGA" (Takeoff/Go-around), "FLX/MCT" (Flex Takeoff/Maximum Continuous Thrust), "CL" (Climb), "IDLE" (Zero Thrust) and "REV" (Reverser). These positions are defined by means of detents, and correspond to the following TLA values:

MAX T.O./GO AROUND (TOGA)	TLA= 45°
FLEX T.O./MAX CONT (FLX/MCT)	TLA= 35°
MAX CLIMB (CL)	TLA= 25°
"IDLE"	TLA= 0°
MAX REVERSE (REV)	TLA= -20°

The autothrust system works from the "IDLE" up to the "FLX/MCT" positions. Basically, when the autothrust system is active, it automatically controls the power, which may vary from "IDLE" up to the limit determined by the lever positioning, that is, "CL" or "FLX/MCT" – so as to maintain a speed or vertical variation rate previously selected by the pilot.

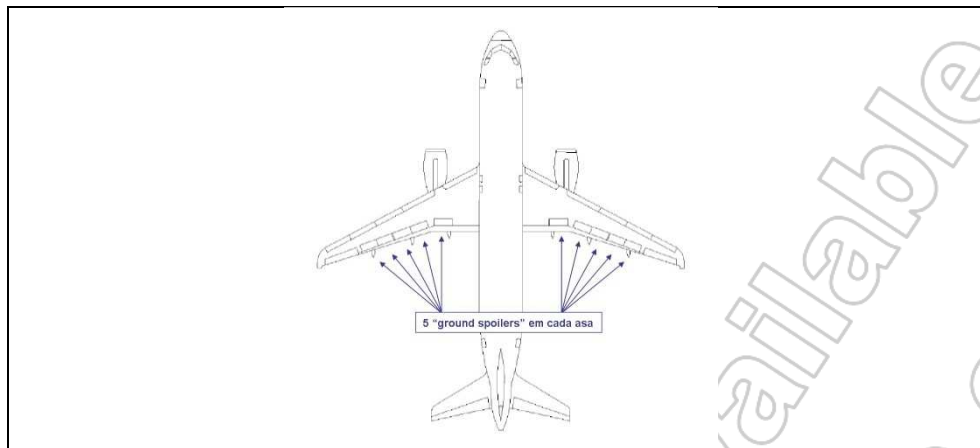
Figure 9 - Ground spoilers: five in each wing.

The A-320 has five spoilers on each wing (figure 9), which open automatically after landing. The spoilers are devices installed on the upper part of the wings whose objective is to reduce lift and increase the aerodynamic drag. During the landing, the device is activated, significantly reducing lift and allowing for a more efficient braking. Consequently, the landing distance of the aircraft is quite reduced.

The automatic ground spoiler function causes the spoilers to open automatically, as soon as the main gears touch the ground, provided the thrust levers are at the "IDLE" position. If one lever stays at the "CL" position during the landing, it deactivates the actuation of the ground spoilers, significantly reducing the aircraft braking capability (between 45% to 50%).
