**Statens haverikommission**  
Swedish Accident Investigation Board

## ***Report RL 2009:19e***

### **Incident involving aircraft HA-LPB over Kalmar county, Sweden on 2 March 2009**

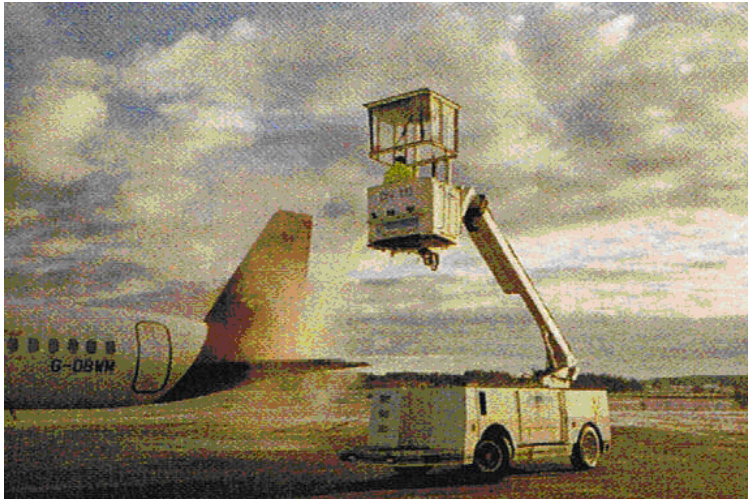
Figure 1. Type DIV 110 de-icing vehicle.

Västerås Flygplats AB has at its disposal for de-icing services a mobile de-icing unit of DIV 110 type, see Figure 1. The unit is operated by one person, who both drives the vehicle and manoeuvres a pivoted de-icing nozzle from a platform on the end of an arm that can be raised and lowered. The vehicle has three fluid tanks, for water, Type I and Type II fluid. The water and Type I tanks are equipped with immersion heaters. The de-icing fluid and water can be mixed in different proportions before the mixture is sprayed on to the aircraft. The mixing proportion is determined by the external air temperature, aircraft skin temperature, precipitation and the desired holdover time in accordance with the tables provided by the fluid manufacturer. The de-icing mixture is set by the operator of the vehicle in accordance with the order from the commander and the table values for the existing conditions.
