Final Report

of AFRIQIYAH Airways Aircraft Airbus A330-202, 5A-ONG Crash Occurred at Tripoli (LIBYA) on 12/05/2010

Published February 2013

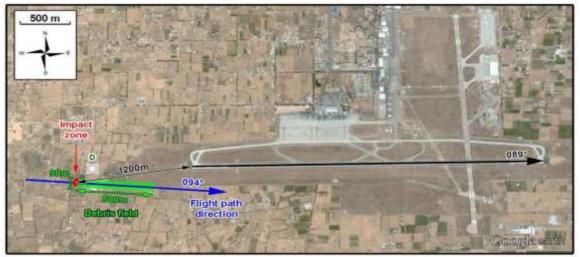
Location of crash site

The impact site was located on a sandy plain dotted with trees, 1,200 m from the threshold of runway 09, at an altitude of about 260 feet, outside the airport. The wreckage was spread over a rectangular area of 800 m long and 90 m wide, oriented 94 degrees, and some debris was found within the airport.

Initial observations show that the aircraft struck the ground with high energy and high longitudinal velocity.

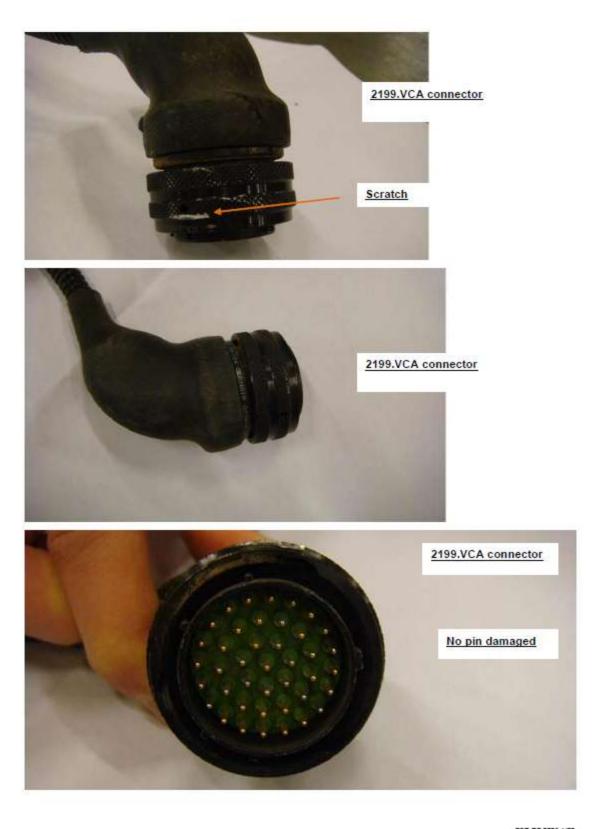
Partial conclusion: scratch on 2199.VCA connector. No cable damaged. No pin damaged.
